MONTEZUMA-CORTEZ SCHOOL DISTRICT RE-1

WORK SESSION AGENDA

Manaugh – Structural Condition Report 2022

Pleasant View - Structural Condition Report 2022

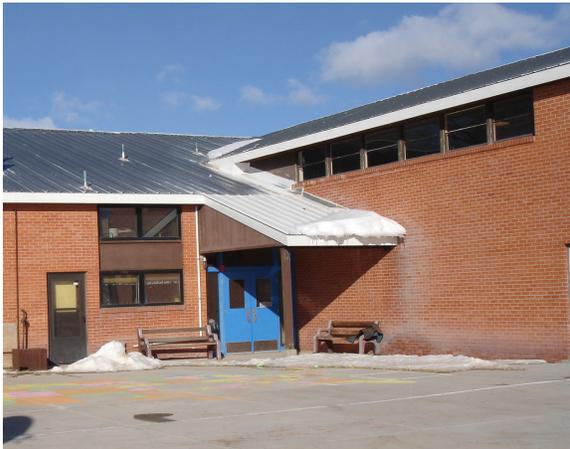
Structural integrity of the shed roof is questionable.

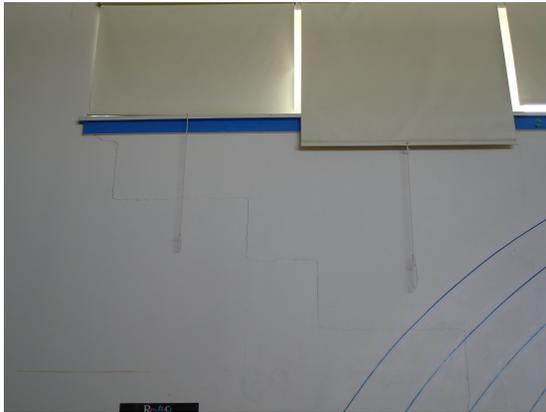
The southeast gymnasium corner of brick veneer had cracked significantly and has displaced about 1/2" to 3/4". This is significant movement and suggests that there has been foundation settlement or possibly separation of the veneer ties from the structural wood-framed wall, maybe both. This condition also exists under the high gym east windows where 4x4 posts between windows support a roof beam. These movements are also evident in the interior east gym wall finishes where stains from past roof leaks are also present.

Cracking that has occurred at the Gymnasium wall.

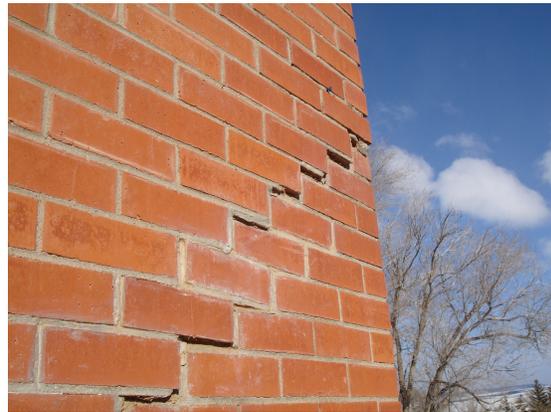
The building's foundation is settling significantly, causing major cracking in the brick veneer. Termites have been found in the building, and although the building has been treated, the extent of the damage has not been fully assessed. Deteriorating ceilings, energy inefficient lighting, a lack of adequate storage, and classrooms which do not accommodate the latest educational models and technologies, are some additional problems, just to name a few. The building was designed at a time when programs and technology were very different, and it can no longer meet current requirements. More importantly, one could argue that it no longer provides spaces which are conducive to the School District's mission. Even with its small enrollment, the building is lacking in many ways. Continued use of the building should be carefully considered.

Significant cracking due to foundation settling.

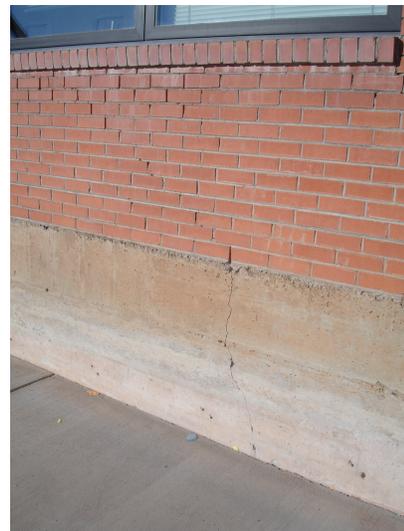
Cracked foundation wall and the deteriorating brick.

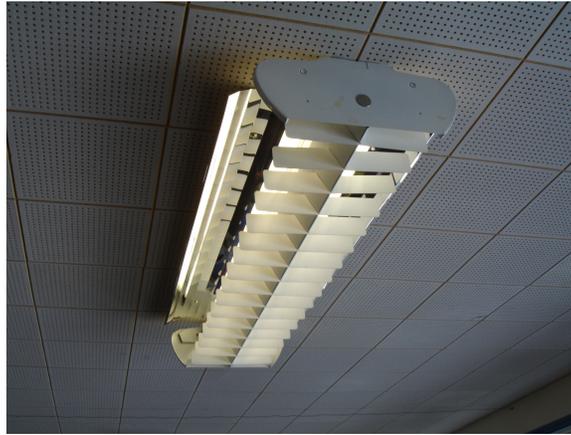
Lighting is minimal and inefficient.

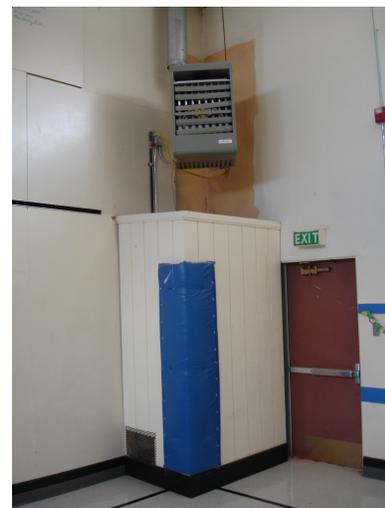
Gas fired heater (open flames) is considered unsafe in schools.

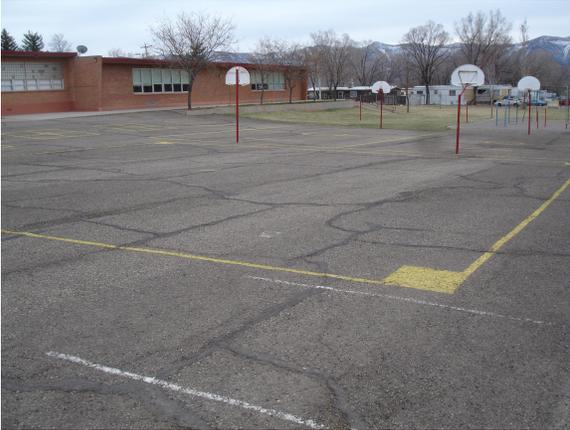
The extensive asphalt play area is in poor condition, it is unattractive, generates heat, and contributes to drainage problems.

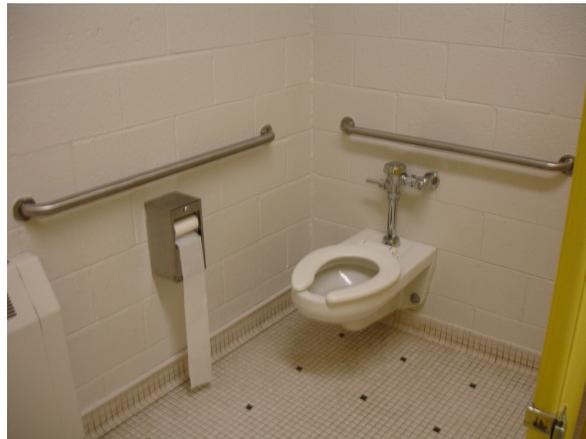
The bathrooms at the addition do not meet accessibility requirements for children.

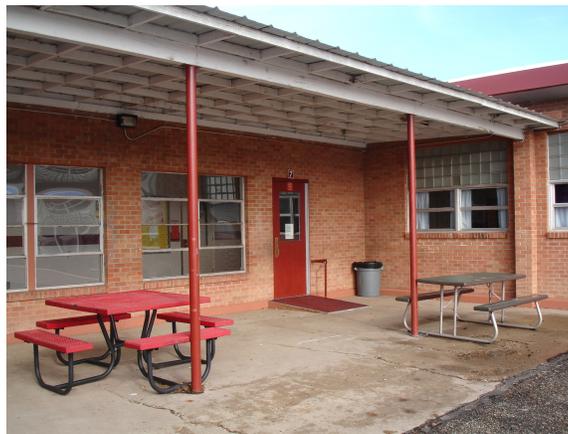
The canopy’s structural adequacy is questionable.

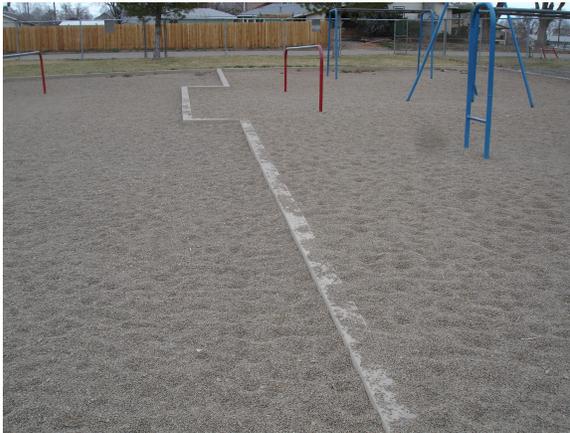
Concrete curb at the play area is unnecessary and a tripping hazard for the students.

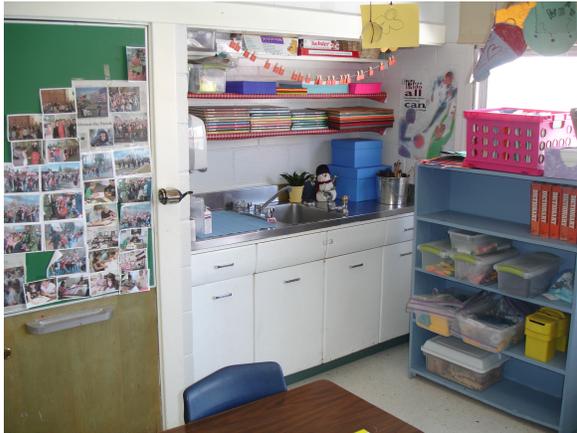
The teacher storage at a original classroom is inadequate and the storage cabinets are dated.

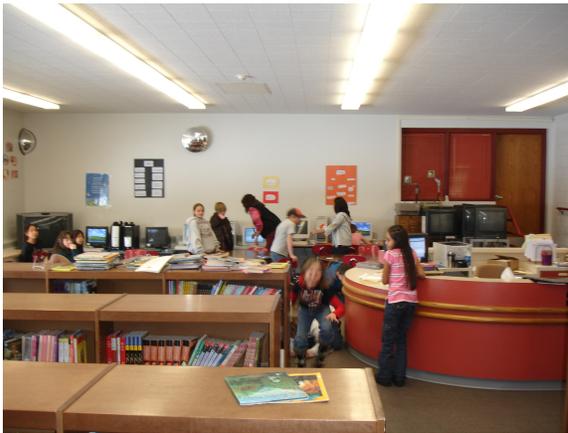
The Media Center lacks storage and is not much more than a large classroom.

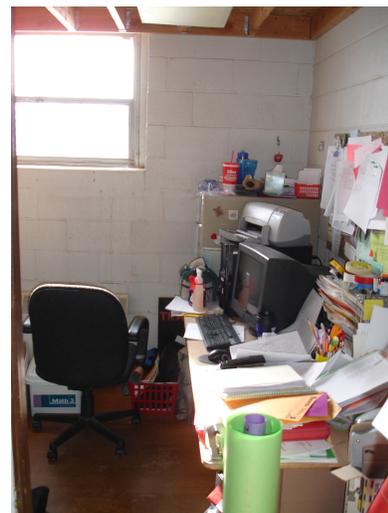
The P.E. teacher's office is inadequate.

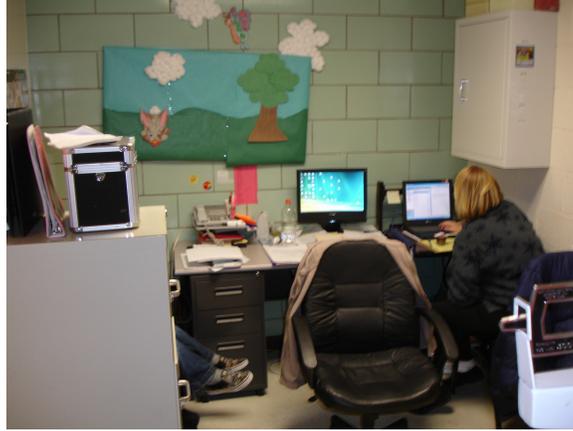
The Nurse's area is very inadequate.

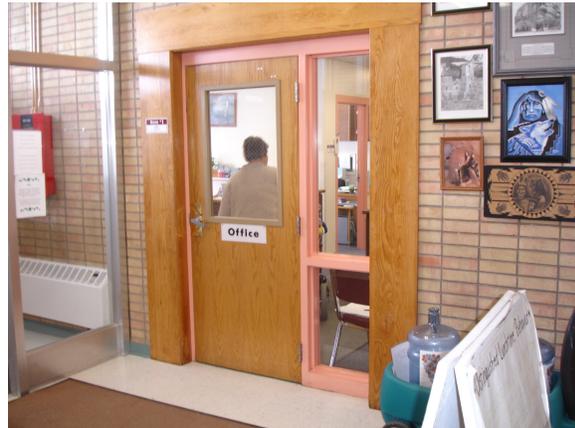
The Administration area provides a minimal view of people entering the building.

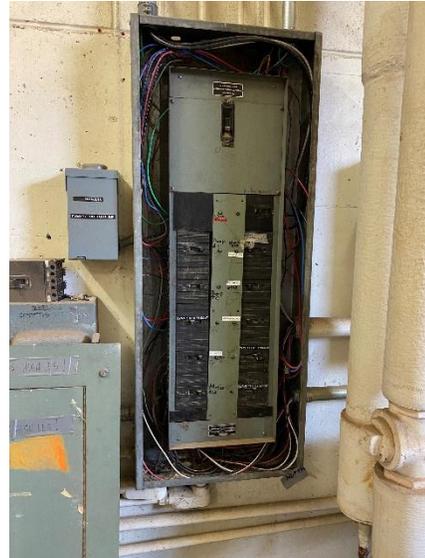
Image 6: Electrical panel with missing cover

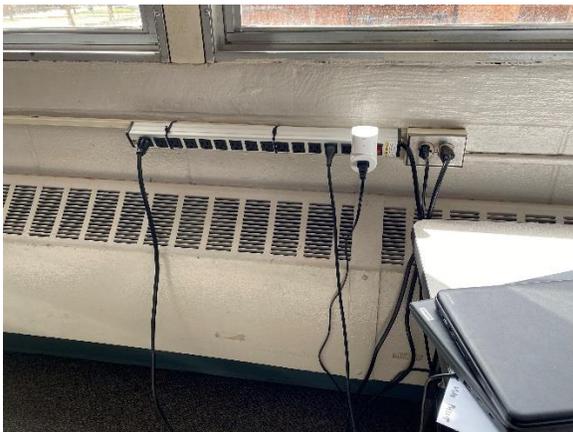
Image 7: Power strip mounted to conduit in classroom
