MONTEZUMA-CORTEZ SCHOOL DISTRICT RE-1

WORK SESSION AGENDA

Manaugh – Structural Condition Report 2022

Pleasant View - Structural Condition Report 2022

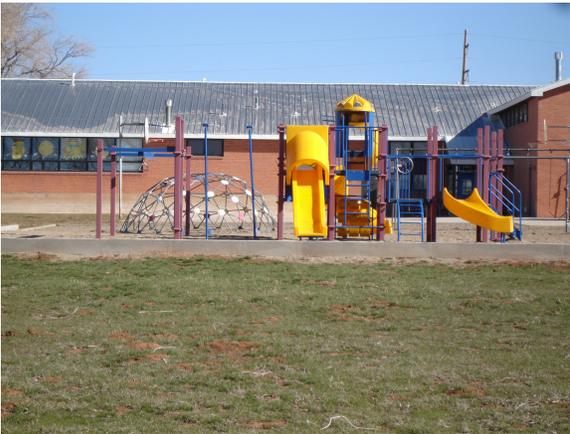
- Directly behind the school (south) there is a concrete play area with stripes for games and a basketball court (2 hoops).
- Beyond the concrete area, further to the south, is a playground with swings, a dome climber, climbing wall, and a play unit (climbers, slide, etc.).
- Just to the west of this area is a merry-go-round and some concrete culvert sections.
- The play unit is newer, but the other equipment is older, but in good condition. The merry-go-round is in poor condition. The concrete is in excellent condition.
- At the northwest corner of the site, there is a baseball backstop.
- There is no fencing around the site.

Satisfactory - 8 out of 10

The playground at the south end of the school building.

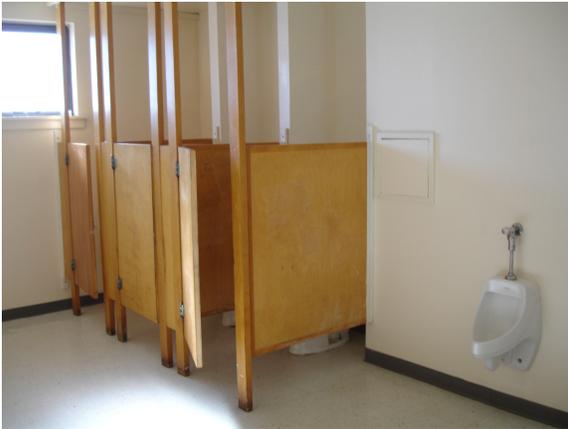
- The plumbing fixture count is adequate based on the 2006 IBC.
- The bathrooms do not meet current accessibility requirements.

Borderline - 6 out of 10

The bathrooms are large, but do not meet accessibility requirements.

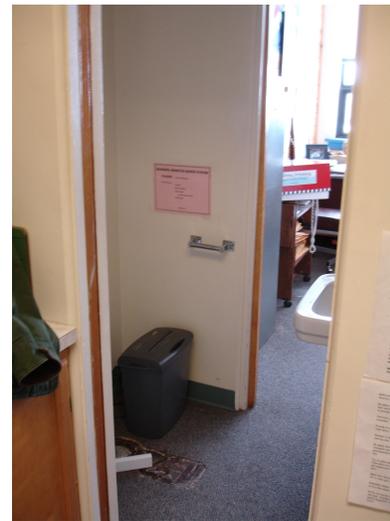
- The building is on a septic system.
- Two toilets were recently removed because of problems with the below slab pipes crushing and becoming unusable.

Poor - 4 out of 10

Bathroom where the toilet has been removed.

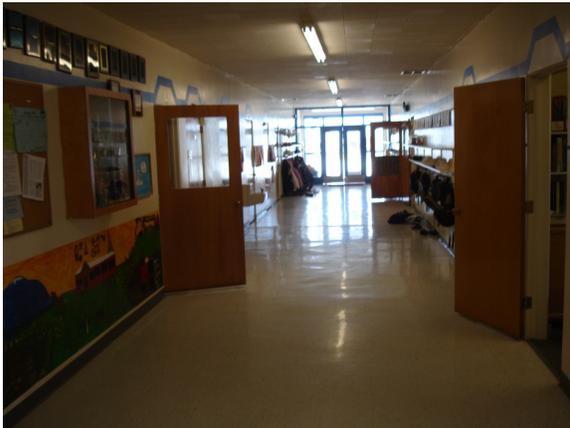
- All classroom doors open outwards.
- None of the classroom doors are recessed, and open into the corridor.

Poor - 4 out of 10

The doors open into the corridor with student storage beyond.

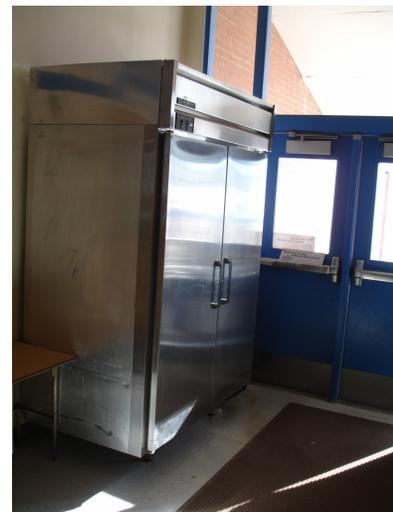
- All traffic areas terminate at an exit.
- The lower exit (south) is partially blocked by a freezer.

Borderline - 3 out of 5

The freezer partially blocks the door.

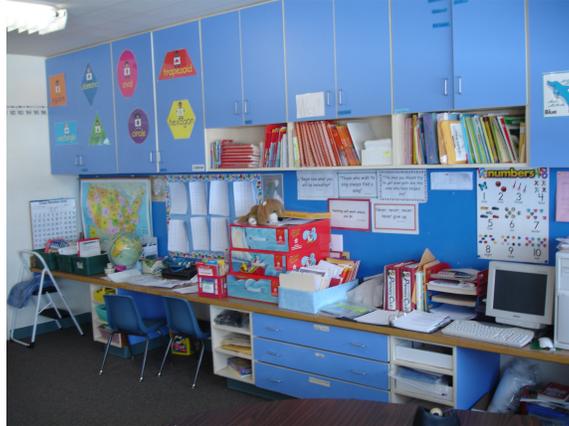
- 5.6 Storage for teacher materials is adequate.
- Teacher storage consists of a wall of built-in casework, including a countertop with drawers, shelves, and work spaces, and upper cabinets. There is also a small storage closet off the corridor which the teachers use.

Borderline – 6 out of 10

The built-in casework provides good storage.

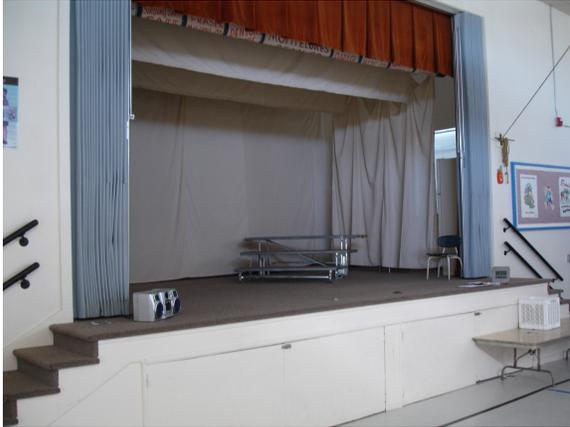
- Music room is too small, lacks sound attenuation materials, and conflicts with the gymnasium.
- A guardrail is not required at an edge of a stage, but when the stage is used as a classroom, there should be a guard. An existing movable partition should be closed when the space is used for music. This would act as a guard, help with sound attenuation, and help to alleviate conflicts with the gymnasium.

Poor - 2 out of 5

The stage is used as a Music Room. The partition should be closed when the stage is used for classes.

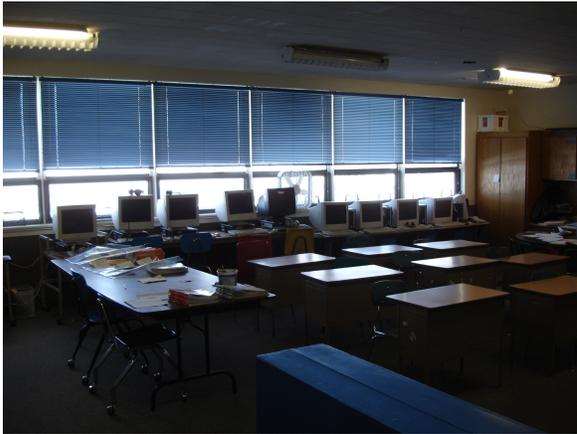
- The staff lounge and workroom are together in a converted classroom, which is also used as a conference room, computer lab, and small group room.
- The staff lounge/workroom has some built-in casework, but no sink, refrigerator, or microwave.
- Tables with seating, work tables, copiers, and paper storage complement the workroom.
- The staff lounge/workroom portion of the room is estimated at about 370s.f. VS 500 – 1000s.f. recommended for each 25 teachers.

Poor - 4 out of 10

A converted classroom is now a workroom, lounge, computer lab, and small group room.

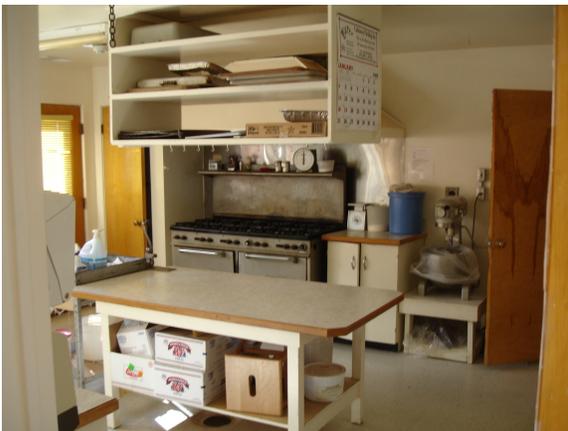
- The gymnasium doubles as the cafeteria
- There is sufficient space for seating, delivery, storage, and food preparation. At 300 square feet, at 2s.f. Per meal served, the kitchen can prepare up to 150 meals.
- The cafeteria can not be set up full time as a cafeteria since the space is shared with the gymnasium

Satisfactory – 8 out of 10

The kitchen equipment is residential grade and is aging.

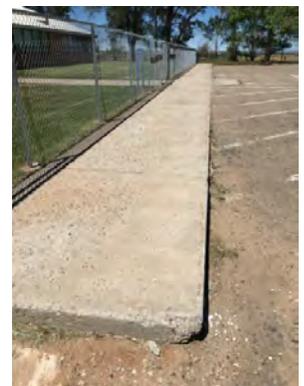
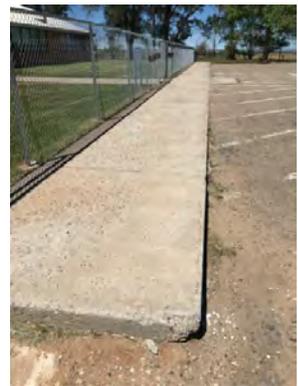
Pedestrian pavement includes 5" thick cast-in-place concrete sidewalk with 2" thick sand bedding. Years remaining have been increased because the system is currently functioning, however the system is beyond its useful life and should be budgeted for repair/replacement.

Cost:	\$32,833	Priority:	3 - Due within 5 Years of Inspection
Action Date:	6/9/25	Prime Sys:	Paving and Surfacing
		Action:	Pedestrian Pavement - Concrete - 1955 Renewal

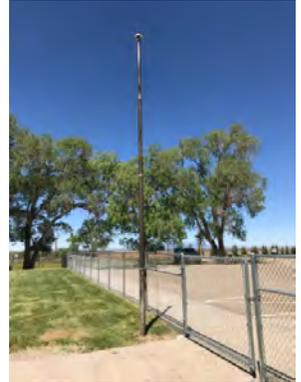
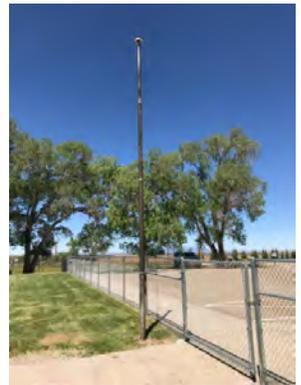
Current Age: 65 years	Year Installed: 1955
Exp. Use. Life: 25 years	Obs. Yrs. Rem: 5 years
Quantity: 1 Each	Unit Cost: \$7,685.05
Insp. Date: 6/9/20	Inspector: Mark Hillen

Site development includes a steel flagpole. Years remaining have been increased because the system is currently functioning, however the system is beyond its useful life and should be budgeted for repair/replacement.

Cost: \$9,606	Priority: 3 - Due within 5 Years of Inspection
Action Date: 6/9/25	Prime Sys: Flagpoles
	Action: Site Development - Flagpoles - Steel Renewal

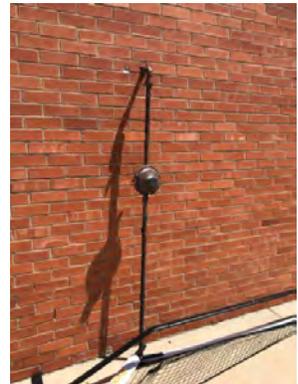
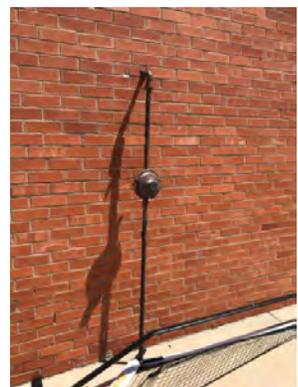
Current Age:	65 years	Year Installed:	1955
Exp. Use. Life:	30 years	Obs. Yrs. Rem:	5 years
Quantity:	180 LF	Unit Cost:	\$24.90
Insp. Date:	6/9/20	Inspector:	Mark Hillen

Fuel distribution includes direct buried propane gas service piping. Years remaining have been increased because the system is currently functioning, however the system is beyond its useful life and should be budgeted for repair/replacement.

Cost:	\$4,707	Priority:	3 - Due within 5 Years of Inspection
Action Date:	6/9/25	Prime Sys:	Fuel Piping
		Action:	Fuel Distribution - Gas Service Piping - 2" Steel Renewal

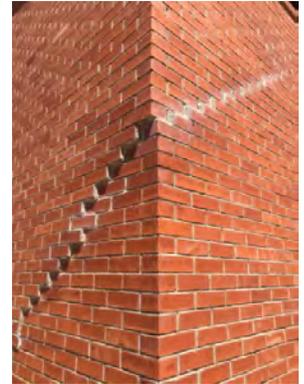
The exterior wall construction is of brick cavity walls with CMU (Concrete Masonry Unit) backup. Exterior walls show signs of cracking and shifting in the past. Repairs have been made.

Exterior walls have shifted, cracked and been repaired in the past. Investigate integrity of exterior walls.

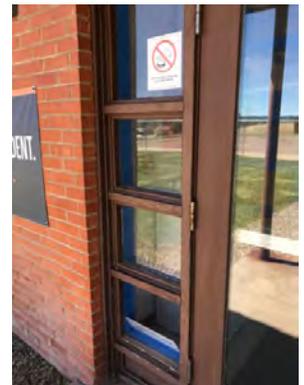
The building includes wood framed exterior window units with insulating glass. Years remaining have been increased because the system is currently functioning, however the system is beyond its useful life and should be budgeted for repair/replacement.

Auto generated renewal for Wood Windows. System Description: The building includes wood framed exterior window units with insulating glass. Years remaining have been increased because the system is currently functioning, however the system is beyond its useful life and should be budgeted for repair/replacement.

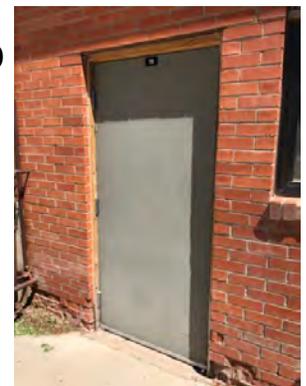
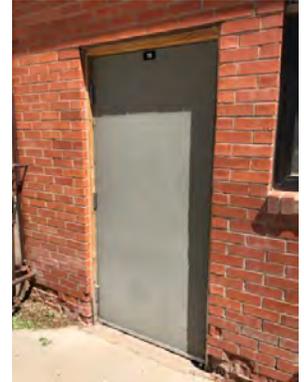
Exterior doors include 3 x 7 HM (Hollow Metal) steel door and steel frame with hinges, lockset, exit hardware and closer. Includes painted door and painted frame. Years remaining have been increased because the system is currently functioning, however the system is beyond its useful life and should be budgeted for repair/replacement.

Cost: \$16,624 **Priority:** 3 - Due within 5 Years of Inspection
Action Date: 6/9/25 **Prime Sys:** Exterior Doors
Action: Door Assembly - 3 x 7 HM - 1990 and Older Renewal

Auto generated renewal for Door Assembly - 3 x 7 HM - 1990 and Older. System Description: Exterior doors include 3 x 7 HM (Hollow Metal) steel door and steel frame with hinges, lockset, exit hardware and closer. Includes painted door and painted frame. Years remaining have been increased because the system is currently functioning, however the system is beyond its useful life and should be budgeted for repair/replacement.

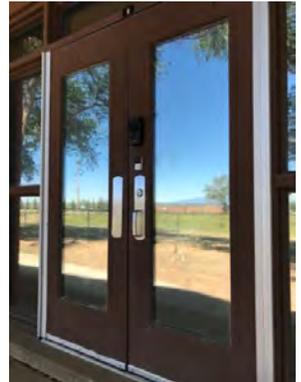
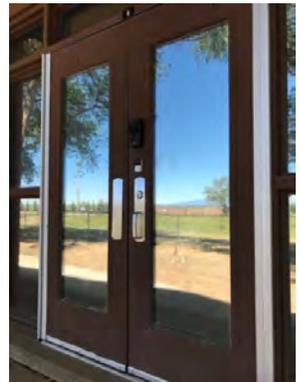
The exterior doors include a pair of 3 x 7 swinging glazed aluminum storefront leafs plus glazed transom, aluminum frame, hardware including closers. Years remaining have been increased because the system is currently functioning, however the system is beyond its useful life and should be budgeted for repair/replacement.

Cost:	\$27,044	Priority:	3 - Due within 5 Years of Inspection
Action Date:	6/9/25	Prime Sys:	Exterior Doors
		Action:	Door Assembly - 6 x 7 Storefront - 1990 and Older Renewal

Auto generated renewal for Door Assembly - 6 x 7 Storefront - 1990 and Older. System Description: The exterior doors include a pair of 3 x 7 swinging glazed aluminum storefront leafs plus glazed transom, aluminum frame, hardware including closers. Years remaining have been increased because the system is currently functioning, however the system is beyond its useful life and should be budgeted for repair/replacement.

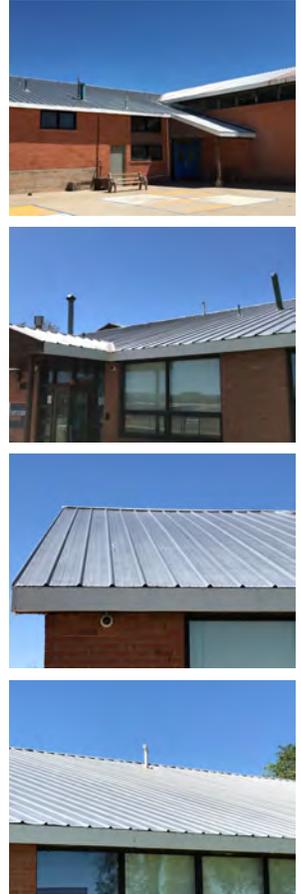
The roof covering consists of a preformed metal roofing system. Years remaining have been increased because the system is currently functioning, however the system is beyond its useful life and should be budgeted for repair/replacement.

Cost: \$160,627 **Priority:** 3 - Due within 5 Years of Inspection
Action Date: 6/9/25 **Prime Sys:** Roofing
Action: Metal Roofing Renewal

Auto generated renewal for Metal Roofing. System Description: The roof covering consists of a preformed metal roofing system. Years remaining have been increased because the system is currently functioning, however the system is beyond its useful life and should be budgeted for repair/replacement.

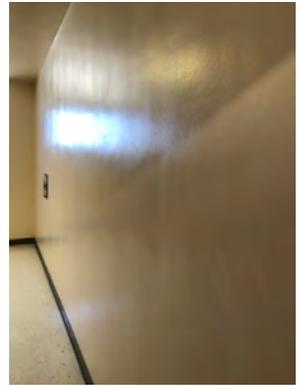
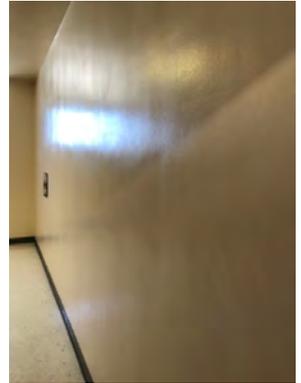
The building interior includes GWB (Gypsum Wall Board) partitions, taped and finished, but not painted. Wall finishes will be addressed in a separate system. Years remaining have been increased because the system is currently functioning, however the system is beyond its useful life and should be budgeted for repair/replacement.

Cost: \$37,251 **Priority:** 3 - Due within 5 Years of Inspection
Action Date: 6/9/25 **Prime Sys:** Partitions
Action: GWB Walls Renewal

Auto generated renewal for GWB Walls. System Description: The building interior includes GWB (Gypsum Wall Board) partitions, taped and finished, but not painted. Wall finishes will be addressed in a separate system. Years remaining have been increased because the system is currently functioning, however the system is beyond its useful life and should be budgeted for repair/replacement.

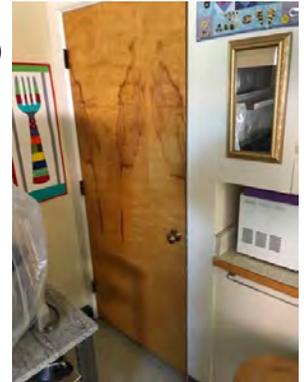
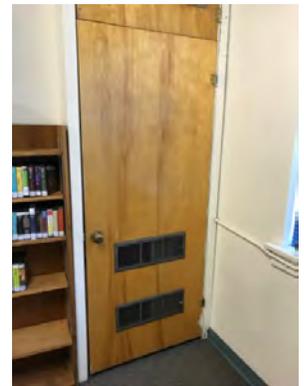
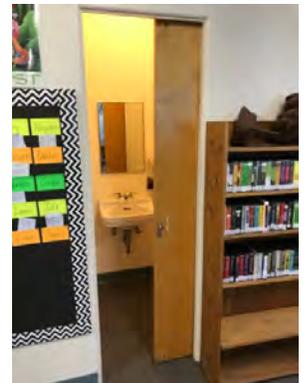
Interior doors include non-rated 3 x 7 Wd (wood) door and frame with hinges, lockset and closer. Includes finished door and frame. Years remaining have been increased because the system is currently functioning, however the system is beyond its useful life and should be budgeted for repair/replacement.

Auto generated renewal for Swinging Doors - 3 x 7 Wd - 1955. System Description: Interior doors include non-rated 3 x 7 Wd (wood) door and frame with hinges, lockset and closer. Includes finished door and frame. Years remaining have been increased because the system is currently functioning, however the system is beyond its useful life and should be budgeted for repair/replacement.

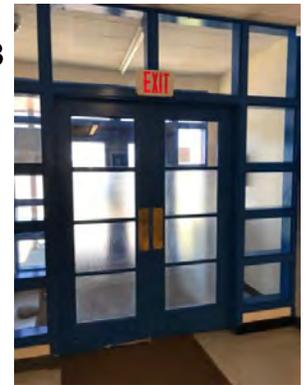
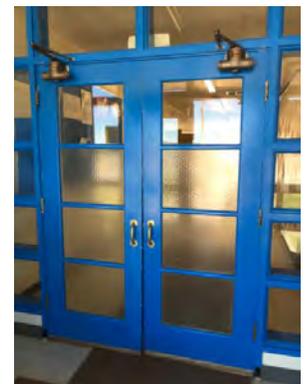
The interior doors include a pair of swinging glazed aluminum storefront with glazed transom, aluminum frame, hardware and closers. Years remaining have been increased because the system is currently functioning, however the system is beyond its useful life and should be budgeted for repair/replacement.

Auto generated renewal for Swinging Doors - 6 x 7 Storefront - 1955. System Description: The interior doors include a pair of swinging glazed aluminum storefront with glazed transom, aluminum frame, hardware and closers. Years remaining have been increased because the system is currently functioning, however the system is beyond its useful life and should be budgeted for repair/replacement.

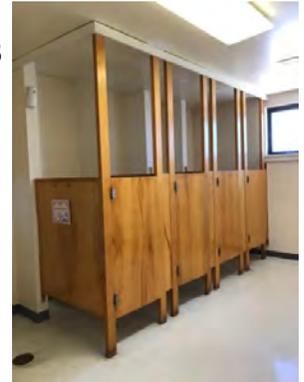
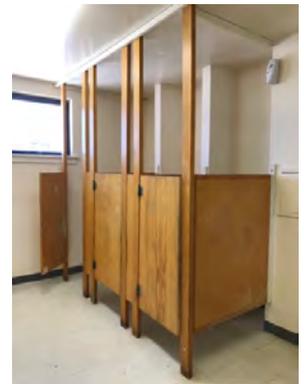
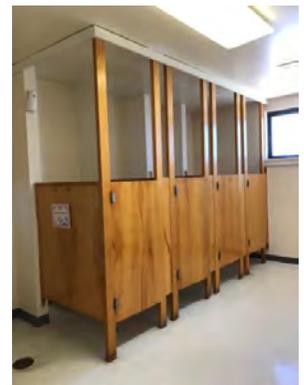
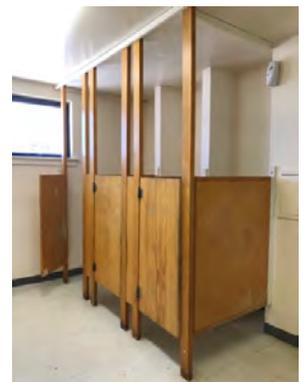
Restrooms are equipped with wall-hung partitions. Years remaining have been increased because the system is currently functioning, however the system is beyond its useful life and should be budgeted for repair/replacement.

Auto generated renewal for Toilet Partitions. System Description: Restrooms are equipped with wall-hung partitions. Years remaining have been increased because the system is currently functioning, however the system is beyond its useful life and should be budgeted for repair/replacement.

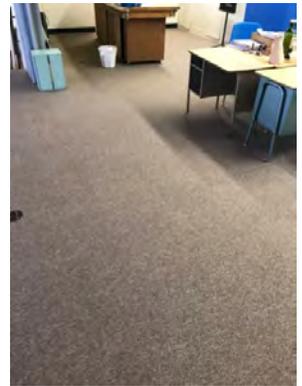
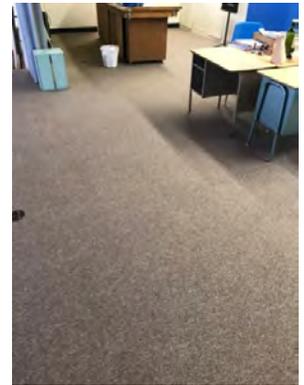
Floor finishes include carpeting and base. Years remaining have been increased because the system is currently functioning, however the system is beyond its useful life and should be budgeted for repair/replacement.

Cost: \$59,297 **Priority:** 3 - Due within 5 Years of Inspection
Action Date: 6/9/25 **Prime Sys:** Floor Finishes
Action: Carpeting - Broadloom - 2010 and Older Renewal

Auto generated renewal for Carpating - Broadloom - 2010 and Older. System Description: Floor finishes include carpeting and base. Years remaining have been increased because the system is currently functioning, however the system is beyond its useful life and should be budgeted for repair/replacement.

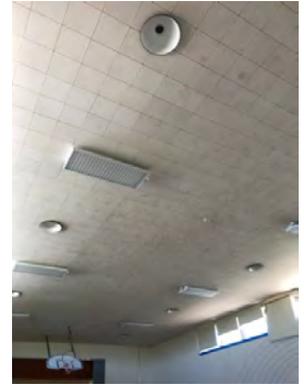
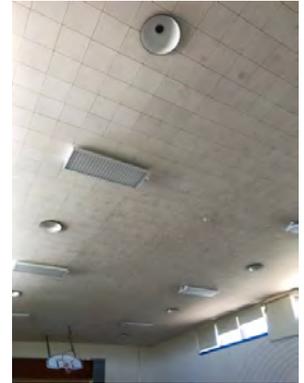
Ceiling finishes included suspended ACT (Acoustic Ceiling Tile) system. Years remaining have been increased because the system is currently functioning, however the system is beyond its useful life and should be budgeted for repair/replacement.

Auto generated renewal for ACT System. System Description: Ceiling finishes included suspended ACT (Acoustic Ceiling Tile) system. Years remaining have been increased because the system is currently functioning, however the system is beyond its useful life and should be budgeted for repair/replacement.

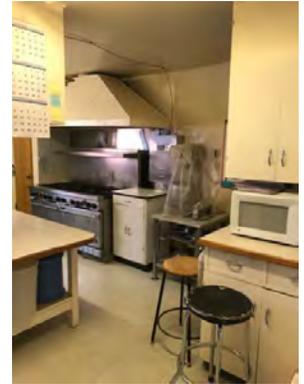
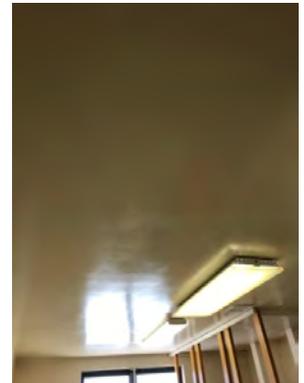
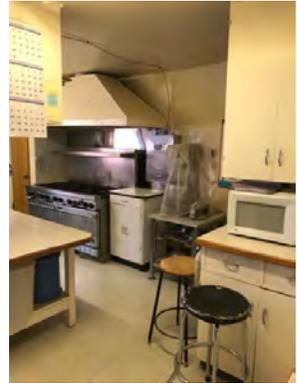
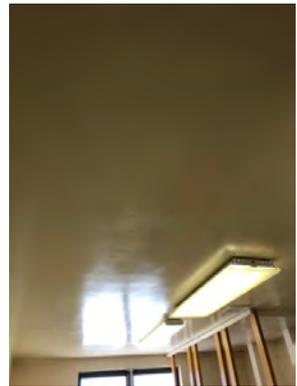
Ceiling finishes include GWB (Gypsum Wall Board) taped, finished and painted with primer and 2 finish coats. Years remaining have been increased because the system is currently functioning, however the system is beyond its useful life and should be budgeted for repair/replacement.

Cost: \$7,800 **Priority:** 3 - Due within 5 Years of Inspection
Action Date: 6/9/25 **Prime Sys:** Ceiling Finishes
Action: **GWB Taped and Finished Renewal**

Auto generated renewal for GWB Taped and Finished. System Description: Ceiling finishes include GWB (Gypsum Wall Board) taped, finished and painted with primer and 2 finish coats. Years remaining have been increased because the system is currently functioning, however the system is beyond its useful life and should be budgeted for repair/replacement.

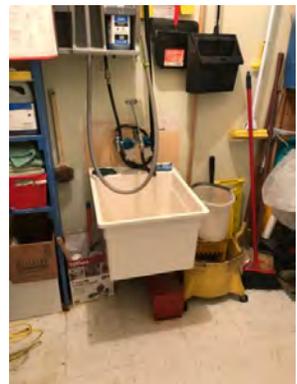
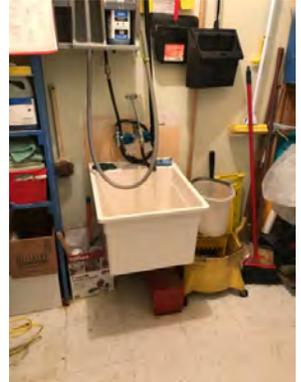
The plumbing fixtures include custodial/utility sinks. Includes rough-in and faucet. Years remaining have been increased because the system is currently functioning, however the system is beyond its useful life and should be budgeted for repair/replacement.

Cost: \$5,156 **Priority:** 3 - Due within 5 Years of Inspection
Action Date: 6/9/25 **Prime Sys:** Plumbing Fixtures
Action: Custodial/Utility Sinks Renewal

Auto generated renewal for Custodial/Utility Sinks. System Description: The plumbing fixtures include custodial/utility sinks. Includes rough-in and faucet. Years remaining have been increased because the system is currently functioning, however the system is beyond its useful life and should be budgeted for repair/replacement.

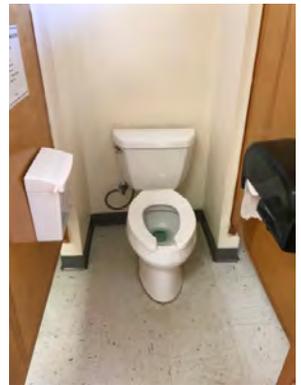
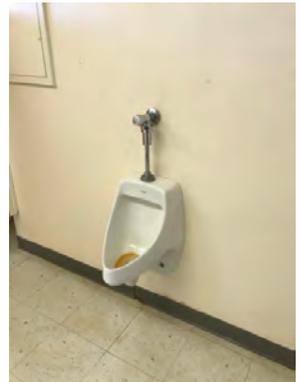
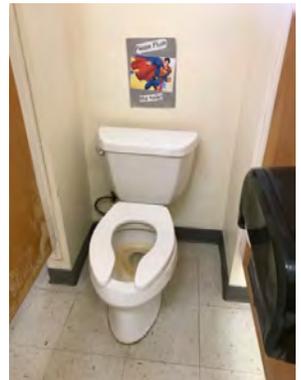
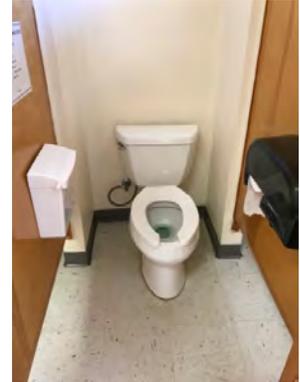
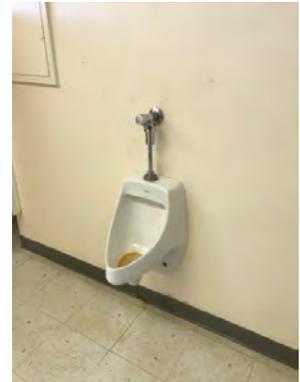
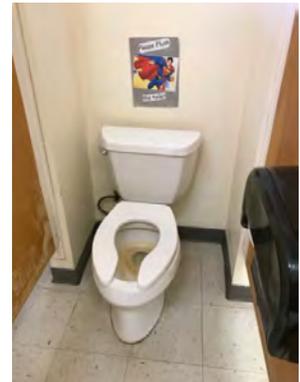
The restroom fixtures include urinals, water closets and lavatories. Years remaining have been increased because the system is currently functioning, however the system is beyond its useful life and should be budgeted for repair/replacement.

Auto generated renewal for Restroom Fixtures - 1990 and Older. System Description: The restroom fixtures include urinals, water closets and lavatories. Years remaining have been increased because the system is currently functioning, however the system is beyond its useful life and should be budgeted for repair/replacement.

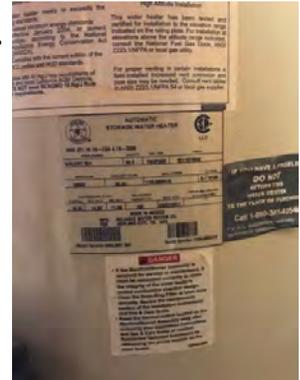
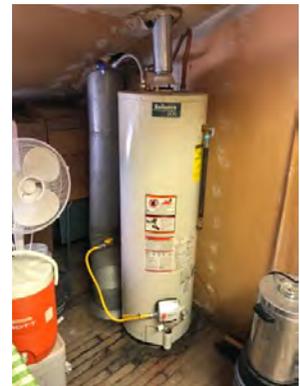
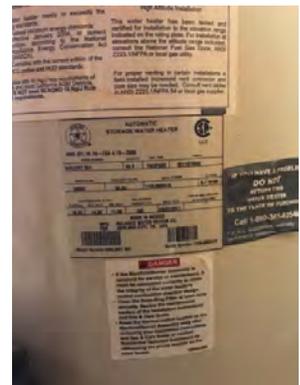
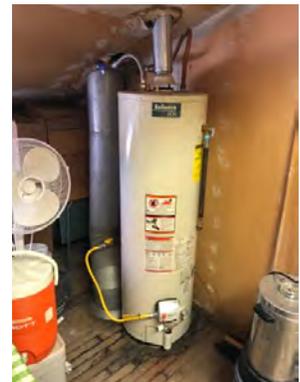
The domestic hot water is provided by a natural gas water heater. Years remaining have been increased because the system is currently functioning, however the system is approaching the end of its useful life and should be budgeted for repair/replacement.

Auto generated renewal for Water Heater - Gas. System Description: The domestic hot water is provided by a natural gas water heater. Years remaining have been increased because the system is currently functioning, however the system is approaching the end of its useful life and should be budgeted for repair/replacement.

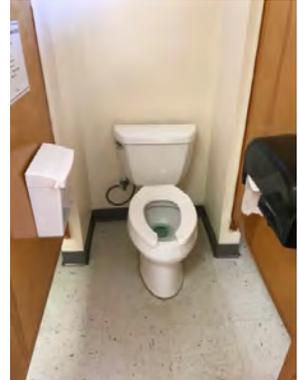
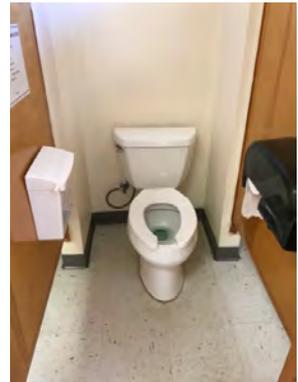
The building includes a sanitary waste system, of cast iron piping, with gravity discharge to the municipal system. Years remaining have been increased because the system is currently functioning, however the system is beyond its useful life and should be budgeted for repair/replacement.

Cost: \$32,443	Priority: 3 - Due within 5 Years of Inspection
Action Date: 6/9/25	Prime Sys: Sanitary Waste
	Action: Sanitary Waste - Gravity Discharge Renewal

Auto generated renewal for Sanitary Waste - Gravity Discharge. System Description: The building includes a sanitary waste system, of cast iron piping, with gravity discharge to the municipal system. Years remaining have been increased because the system is currently functioning, however the system is beyond its useful life and should be budgeted for repair/replacement.

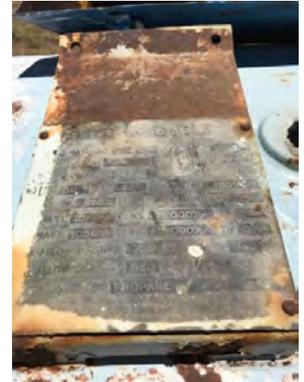
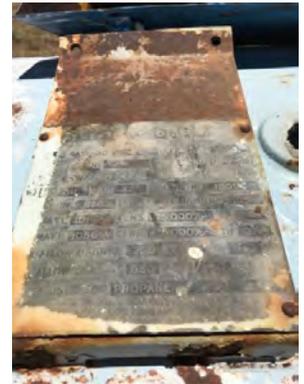
The building includes a 1000 gallon horizontal steel aboveground propane tank with first stage pressure regulator and supply line to building. Years remaining have been increased because the system is currently functioning, however the system is beyond its useful life and should be budgeted for repair/replacement.

Cost:	\$15,421	Priority:	3 - Due within 5 Years of Inspection
Action Date:	6/9/25	Prime Sys:	Gas Supply System
		Action:	Propane Tank - 1000 Gallons Renewal

Auto generated renewal for Propane Tank - 1000 Gallons. System Description: The building includes a 1000 gallon horizontal steel aboveground propane tank with first stage pressure regulator and supply line to building. Years remaining have been increased because the system is currently functioning, however the system is beyond its useful life and should be budgeted for repair/replacement.

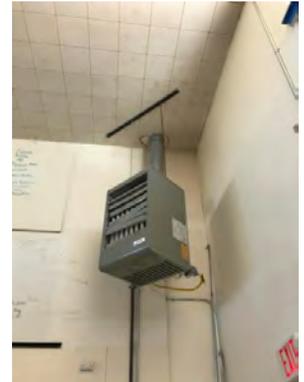
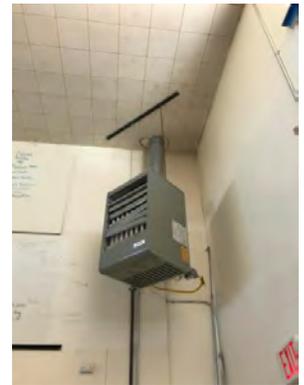
Heating is provided by suspended, gas-fired unit heaters. Years remaining have been increased because the system is currently functioning, however the system is beyond its useful life and should be budgeted for repair/replacement.

Cost:	\$7,046	Priority:	3 - Due within 5 Years of Inspection
Action Date:	6/9/25	Prime Sys:	Terminal and Package Units
		Action:	Unit Heaters - Gas Fired Renewal

Auto generated renewal for Unit Heaters - Gas Fired. System Description: Heating is provided by suspended, gas-fired unit heaters. Years remaining have been increased because the system is currently functioning, however the system is beyond its useful life and should be budgeted for repair/replacement.

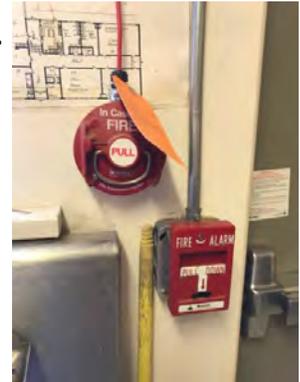
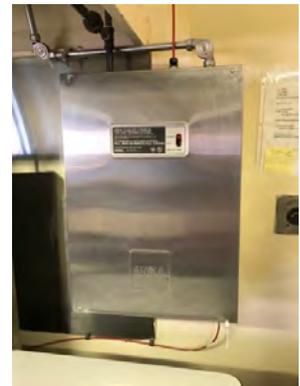
System includes a chemical fire suppression system for the kitchen. Fire suppression includes fusible links, manual pull stations, 3 gallon tanks, nozzles, and control panels. Hood included under a separate system. This system is approaching the end of its useful life and should be budgeted for repair/replacement.

Auto generated renewal for Kitchen Hood Suppression. System Description: System includes a chemical fire suppression system for the kitchen. Fire suppression includes fusible links, manual pull stations, 3 gallon tanks, nozzles, and control panels. Hood included under a separate system. This system is approaching the end of its useful life and should be budgeted for repair/replacement.

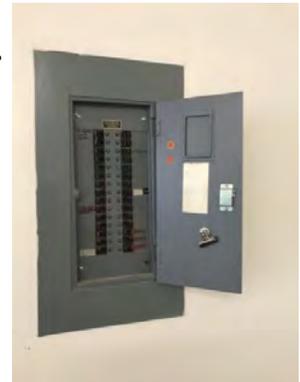
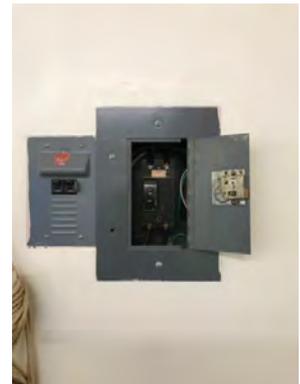
The electrical distribution system for this building includes panelboards, feeders, and associated equipment. Years remaining have been increased because the system is currently functioning, however the system is beyond its useful life and should be budgeted for repair/replacement.

Distribution Equipment, Panelboards, and Feeders - 200A 208Y/120V - 1955 Renewal

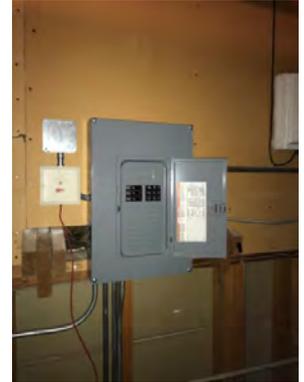
The electrical distribution system for this building includes panelboards, feeders, and associated equipment. Years remaining have been increased because the system is currently functioning, however the system is beyond its useful life and should be budgeted for repair/replacement.

Distribution Equipment, Panelboards, and Feeders - 200A 208Y/120V -1988 Renewal

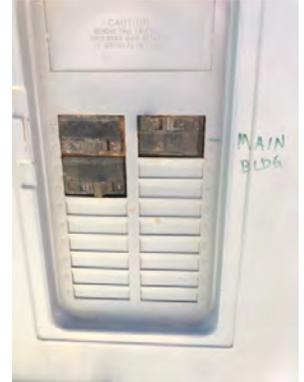
The building includes an electrical service, which includes incoming feeders, main panel, and metering. Years remaining have been increased because the system is currently functioning, however the system is beyond its useful life and should be budgeted for repair/replacement.

Main Electrical Service - 200A 208Y/120V Renewal

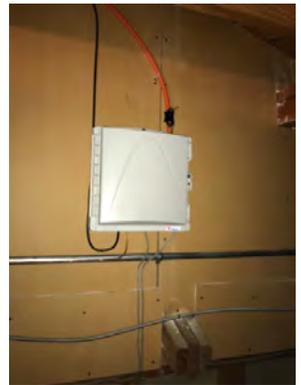
The building includes a telephone system. Years remaining have been increased because the system is currently functioning, however the system is beyond its useful life and should be budgeted for repair/replacement.

Telephone System - 2010 and Older Renewal

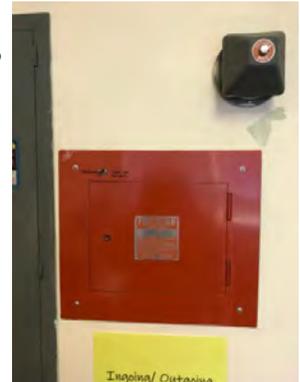
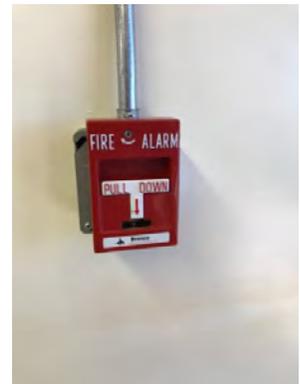
The fire alarm system includes head end equipment, pull stations, audio/visual strobes, visual strobes, smokes, conduit, wire and connections. Years remaining have been increased because the system is currently functioning, however the system is beyond its useful life and should be budgeted for repair/replacement.

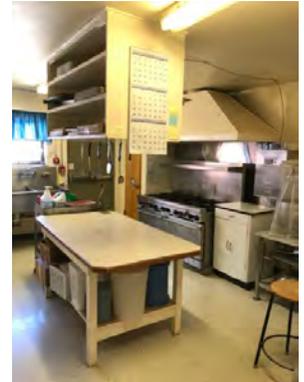
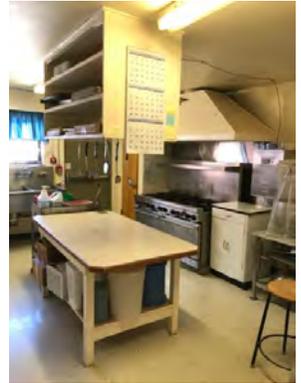
Equipment and furnishings includes kitchen equipment. Years remaining have been increased because the system is currently functioning, however the system is beyond its useful life and should be budgeted for repair/replacement.

Kitchen Equipment Renewal

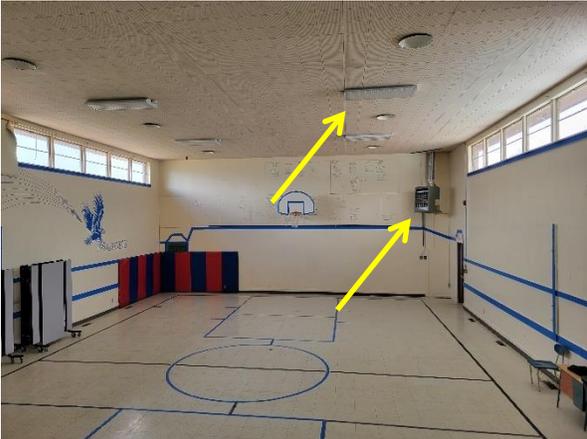
Image 1: Gym (unit heater & lighting)

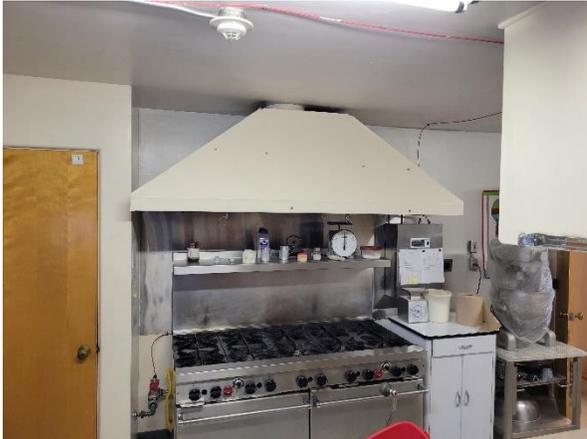
Image 2: Kitchen Hood

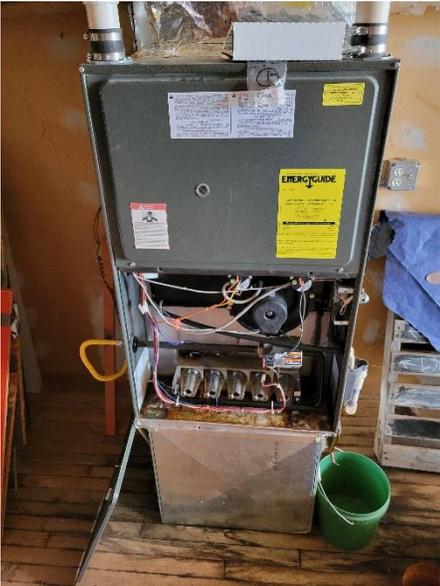
Image 3: Typical Furnace

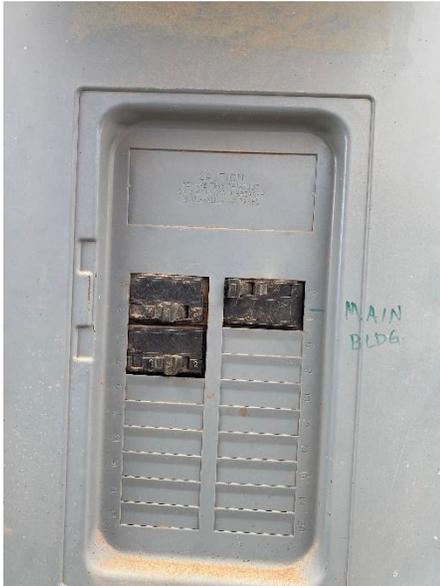
Image 4: Main Electrical Service to Site

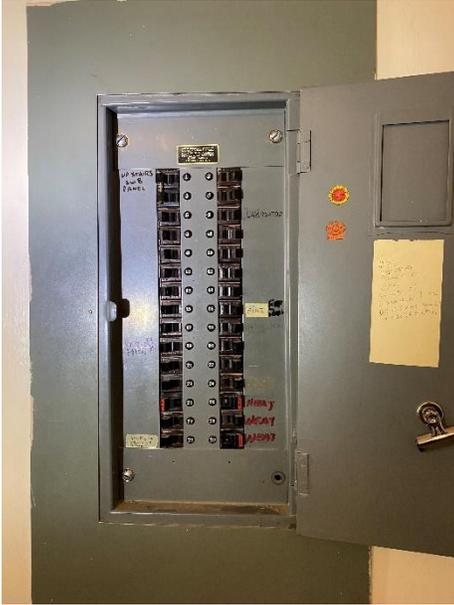
Image 5: Main panelboard in School

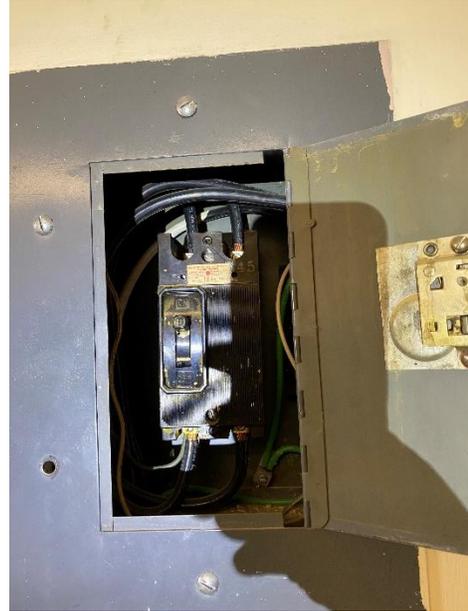
Image 6: Main breaker in school.

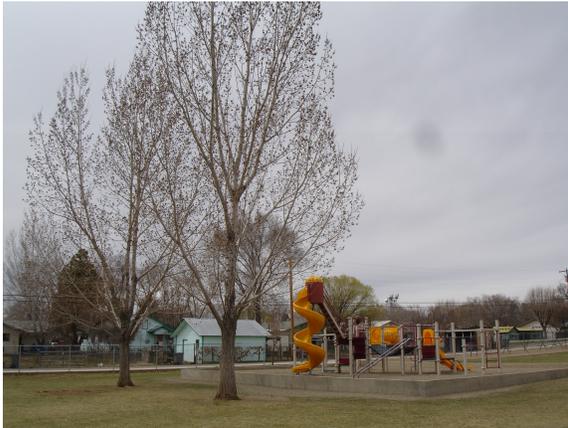
- The majority of the site is covered with grass except the alley to the east, the parking lot to the west, the asphalt play area, and the areas around the play equipment
- Mature trees enhance the appearance of the front (north) of the building as well as the back and west side of the building. They also provide shade for west facing windows and play equipment.

Trees provide some shade during the summer for the play areas.

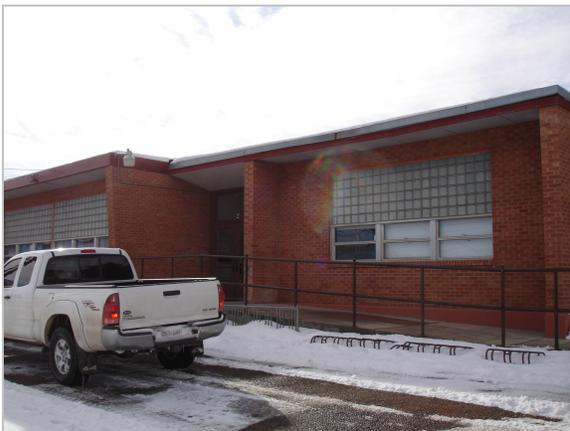
- There is only one handicapped space provided on the site, although there should be two. There is, however, about forty-five feet of curb on Fourth Street for Handicapped drop-off and parking, but this technically is not part of the school's site.

Parking at the northeast corner could be an ambulance loading space.

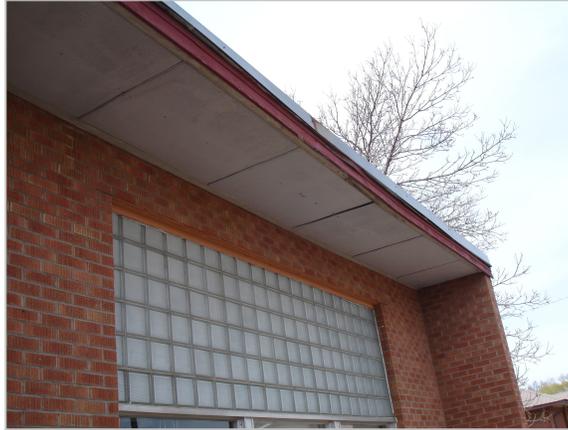
- Asbestos flooring has been abated
- Transite panels at the building’s exterior (soffit panels) are still in place, but asbestos in them is not friable unless the panels are cut.
- Asbestos pipe insulation is still in the building.

Transite (asbestos) soffit panels.

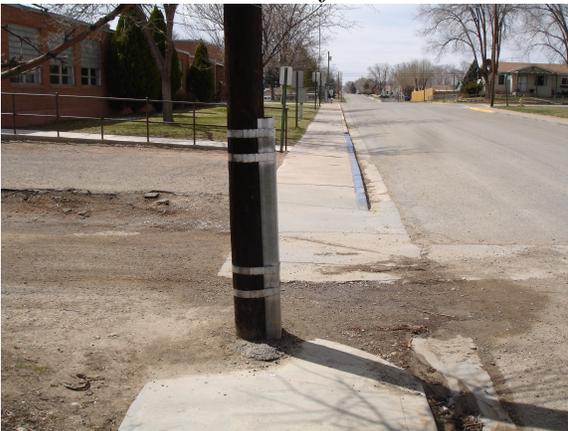
- 4.2 Walkways, both on and off site, are available for safety of pedestrians.
- Pedestrian access from the south is provided via a gate to the trailer park, but there is not a sidewalk that serves either side of it.
 - Alleys are to the east and west of the site. No sidewalk is provided at the east alley. At the west alley, there is a section of sidewalk for the bus loading area.
 - Sidewalks at the north (front) of the building are adequate with crosswalks, but no curb cuts. The sidewalk that crosses the east alley can become muddy, and there is a power pole blocking it.
 - Sidewalks and curb cuts at surrounding blocks are minimal to non-existent, making pedestrian access to the building difficult, especially when the ground is wet or snow covered.

The power pole and mud from the alley at the northeast make pedestrian access difficult.

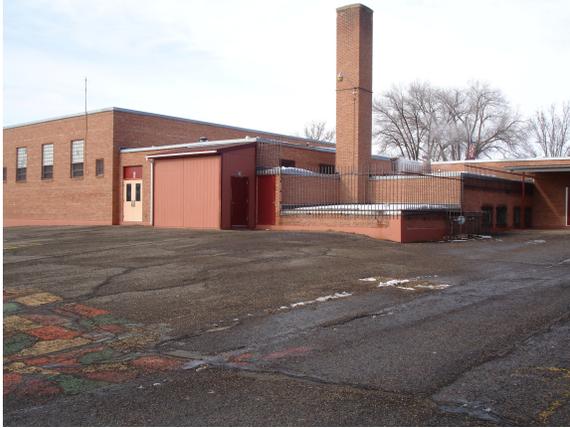
- There is one mechanical room in the building at the west end, in the original structure. This area is not readily accessible from the interior of the building, but it is adjacent to the play area.

This is the mechanical area adjacent to the play area.

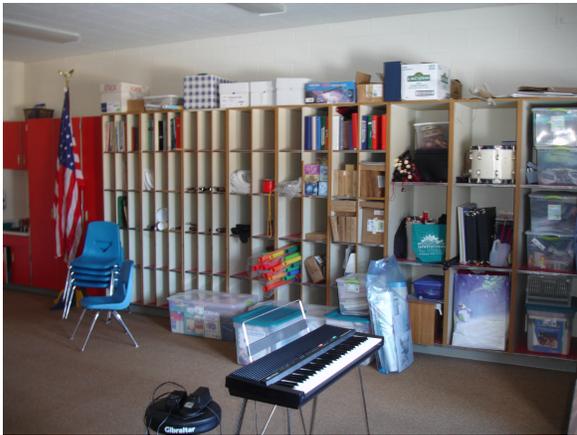
- The space is adequate for the music program as long as a class is no larger than 26 students.
- There is no sound treatment in the space other than the standard classroom finishes (flooring is carpet, and the ceiling is acoustical ceiling tile).

The built-ins in the Music Room provide good storage.

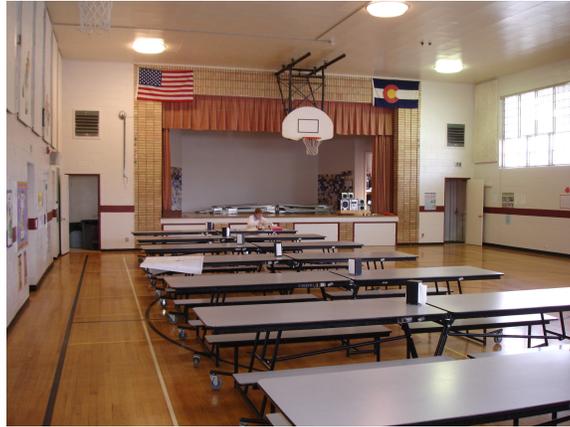
- The cafeteria cannot be set up full time as cafeteria since the space is shared with the gymnasium.
- There is no storage for the tables which sit (folded) along the gymnasium wall when not being used. This can cause conflicts with PE classes.
- The heaters are loud and have to be turned off during assemblies.

The school gymnasium is used as the cafeteria.

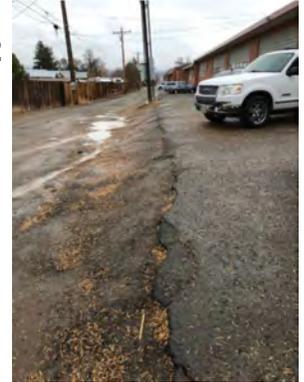
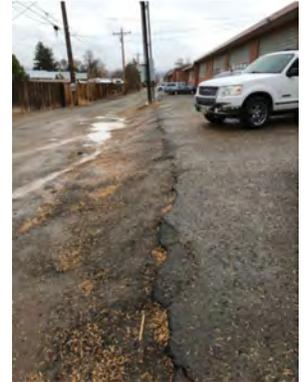
Parking lot and roadway flexible pavement includes a 2" thick bituminous wearing surface course for large paved areas. Years remaining have been increased because the system is currently functioning, however the system is beyond its useful life and should be budgeted for repair/replacement.

Auto generated renewal for Parking Lot and Roadway Flexible Pavement - Surface Course. System Description: Parking lot and roadway flexible pavement includes a 2" thick bituminous wearing surface course for large paved areas. Years remaining have been increased because the system is currently functioning, however the system is beyond its useful life and should be budgeted for repair/replacement.

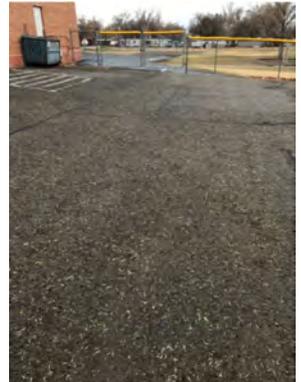
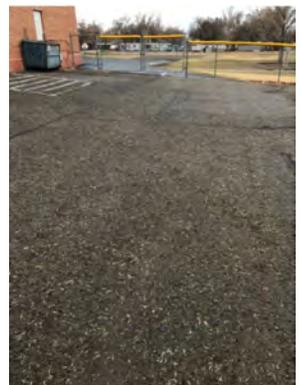
Current Age:	10 years	Year Installed:	2010
Exp. Use. Life:	10 years	Obs. Yrs. Rem:	3 years
Quantity:	44 Each	Unit Cost:	\$59.95
Insp. Date:	3/10/20	Inspector:	Mark Hillen

Cost:	\$3,034	Priority:	3 - Due within 5 Years of Inspection
Action Date:	3/10/23	Prime Sys:	Markings and Signage
		Action:	Parking Lot - Traffic Control - Painted Pavement Markings Renewal

Auto generated renewal for Parking Lot - Traffic Control - Painted Pavement Markings. System Description: Parking lot includes painted pavement markings used to provide guidance and information to drivers and pedestrians. Includes parking space, directional arrows, crosswalk, accessibility and other parking lot graphics. Years remaining have been increased because the system is currently functioning, however the system is beyond its useful life and should be budgeted for repair/replacement.

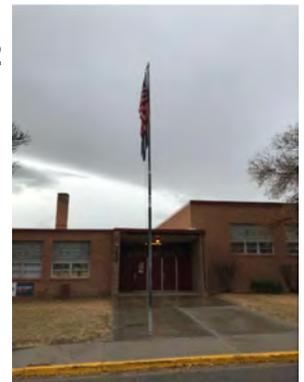
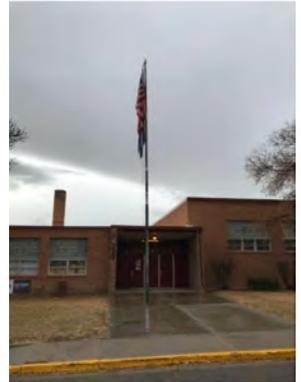
Site development includes aluminum flagpoles. Years remaining have been increased because the system is currently functioning, however the system is beyond its useful life and should be budgeted for repair/replacement.

Cost: \$8,640 **Priority:** 3 - Due within 5 Years of Inspection
Action Date: 3/10/25 **Prime Sys:** Flagpoles
Action: Site Development - Flagpoles - Steel Renewal

Auto generated renewal for Site Development - Flagpoles - Steel. System Description: Site development includes aluminum flagpoles. Years remaining have been increased because the system is currently functioning, however the system is beyond its useful life and should be budgeted for repair/replacement.

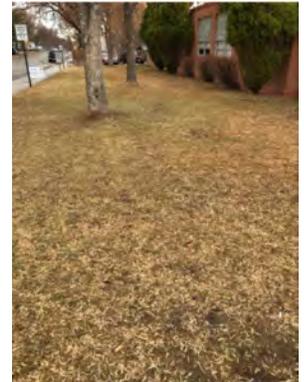
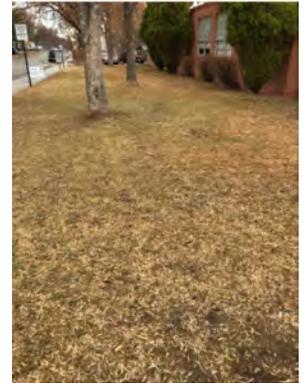
Landscaping includes graded, sodded grass areas. Note - irrigation is a separate system. Years remaining have been increased because the system is currently functioning, however the system is beyond its useful life and should be budgeted for repair/replacement.

Auto generated renewal for Landscaping - Grass Sodding. System Description: Landscaping includes graded, sodded grass areas. Note - irrigation is a separate system. Years remaining have been increased because the system is currently functioning, however the system is beyond its useful life and should be budgeted for repair/replacement.

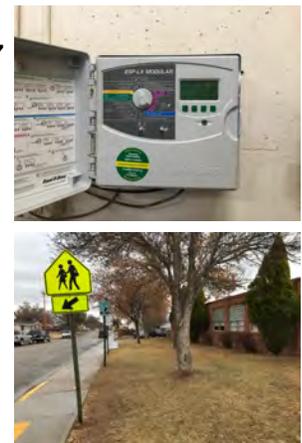
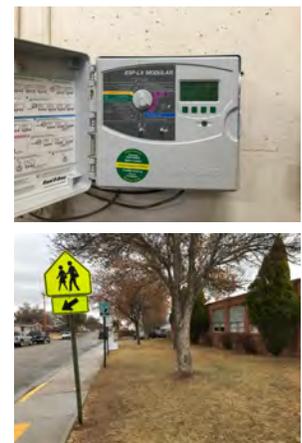
Landscaping includes an irrigation system typical for grass areas; estimated 2 inch supply line. Years remaining have been increased because the system is currently functioning, however the system is approaching the end of its useful life and should be budgeted for repair/replacement.

Auto generated renewal for Landscaping - Sprinkler System. System Description: Landscaping includes an irrigation system typical for grass areas; estimated 2 inch supply line. Years remaining have been increased because the system is currently functioning, however the system is approaching the end of its useful life and should be budgeted for repair/replacement.

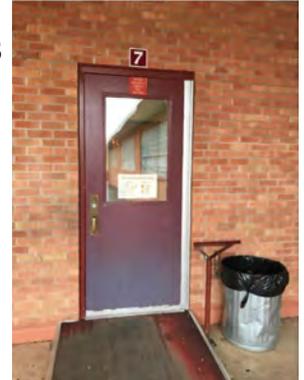
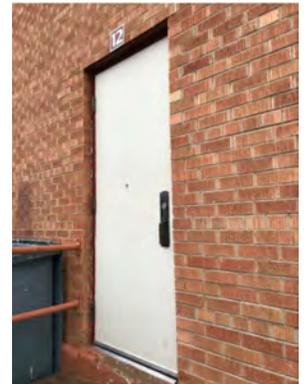
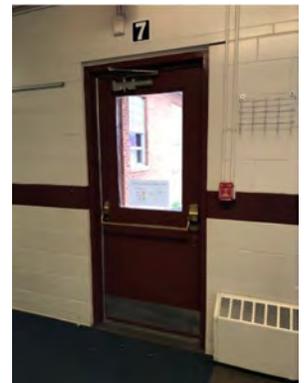
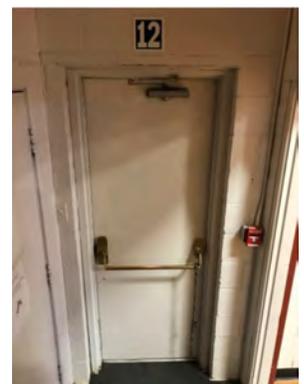
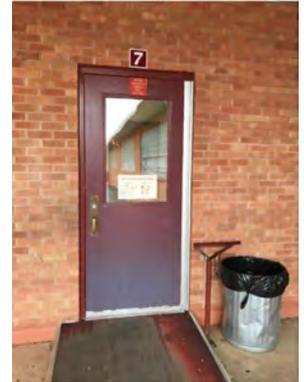
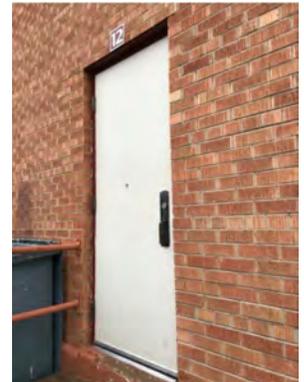
Exterior doors include 3 x 7 HM (Hollow Metal) steel door and steel frame with hinges, lockset, exit hardware and closer. Includes painted door and painted frame. Years remaining have been increased because the system is currently functioning, however the system is beyond its useful life and should be budgeted for repair/replacement.

Auto generated renewal for Door Assembly - 3 x 7 HM - 1955. System Description: Exterior doors include 3 x 7 HM (Hollow Metal) steel door and steel frame with hinges, lockset, exit hardware and closer. Includes painted door and painted frame. Years remaining have been increased because the system is currently functioning, however the system is beyond its useful life and should be budgeted for repair/replacement.
