MONTEZUMA-CORTEZ SCHOOL DISTRICT RE-1

WORK SESSION AGENDA

Manaugh – Structural Condition Report 2022

Pleasant View - Structural Condition Report 2022

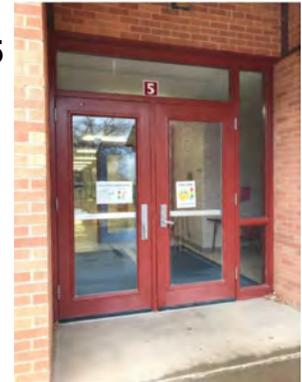
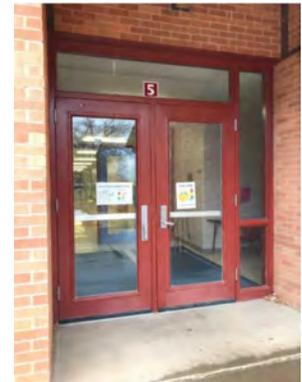
The exterior doors include a pair of 3 x 7 swinging glazed aluminum storefront leaves plus glazed transom, aluminum frame, hardware including closers. Years remaining have been increased because the system is currently functioning, however the system is beyond its useful life and should be budgeted for repair/replacement.

Auto generated renewal for Door Assembly - 6 x 7 Storefront - 1986. System Description: The exterior doors include a pair of 3 x 7 swinging glazed aluminum storefront leaves plus glazed transom, aluminum frame, hardware including closers. Years remaining have been increased because the system is currently functioning, however the system is beyond its useful life and should be budgeted for repair/replacement.

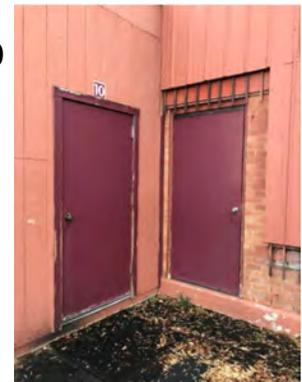
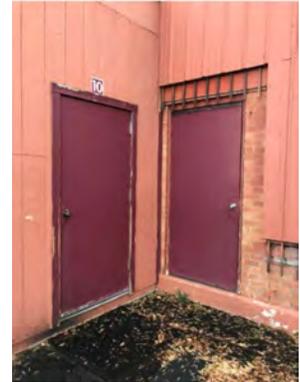
Exterior doors include 3 x 7 wood door and frame with hinges, lockset, exit hardware and closer. Includes painted door and painted frame. Years remaining have been increased because the system is currently functioning, however the system is beyond its useful life and should be budgeted for repair/replacement.

Cost: \$14,200 **Priority:** 3 - Due within 5 Years of Inspection
Action Date: 3/10/24 **Prime Sys:** Exterior Doors
Action: Door Assembly - 3 x 7 Wood - 1955 Renewal

Auto generated renewal for Door Assembly - 3 x 7 Wood - 1955. System Description: Exterior doors include 3 x 7 wood door and frame with hinges, lockset, exit hardware and closer. Includes painted door and painted frame. Years remaining have been increased because the system is currently functioning, however the system is beyond its useful life and should be budgeted for repair/replacement.

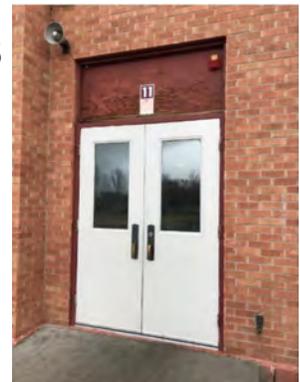
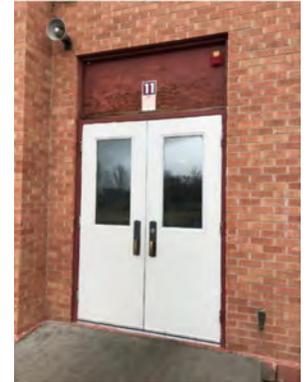
Exterior doors include a pair of 3 x 7 HM (Hollow Metal) steel doors and steel frame with hinges, locksets, exit hardware and closers. Includes painted doors and painted frame. Years remaining have been increased because the system is currently functioning, however the system is beyond its useful life and should be budgeted for repair/replacement.

Cost:	\$10,893	Priority:	3 - Due within 5 Years of Inspection
Action Date:	3/10/25	Prime Sys:	Exterior Doors
		Action:	Door Assembly - 6 x 7 HM - 1955 Renewal

Auto generated renewal for Door Assembly - 6 x 7 HM - 1955. System Description: Exterior doors include a pair of 3 x 7 HM (Hollow Metal) steel doors and steel frame with hinges, locksets, exit hardware and closers. Includes painted doors and painted frame. Years remaining have been increased because the system is currently functioning, however the system is beyond its useful life and should be budgeted for repair/replacement.

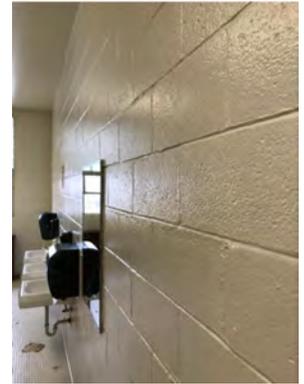
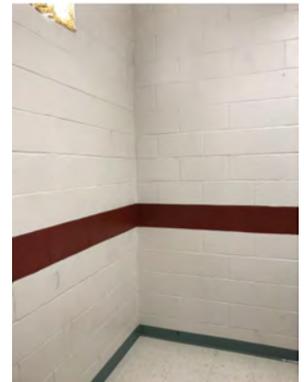
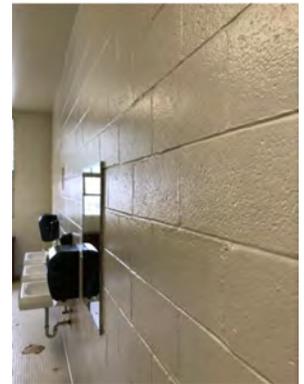
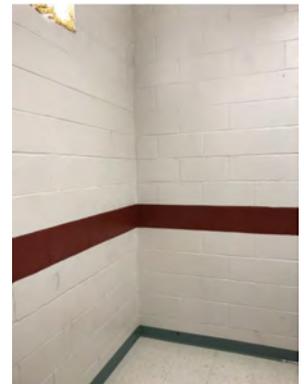
Interior wall construction includes 8-in. CMU (Concrete Masonry Unit) walls with no finish. Wall finishes will be addressed in a separate system. Years remaining have been increased because the system is currently functioning, however the system is beyond its useful life and should be budgeted for repair/replacement.

Auto generated renewal for CMU Block Walls - Plain - 1955. System Description: Interior wall construction includes 8-in. CMU (Concrete Masonry Unit) walls with no finish. Wall finishes will be addressed in a separate system. Years remaining have been increased because the system is currently functioning, however the system is beyond its useful life and should be budgeted for repair/replacement.

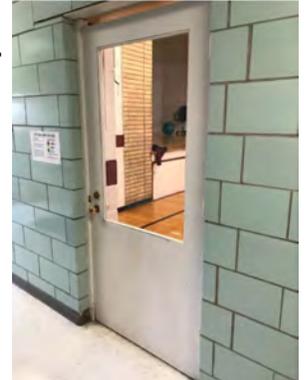
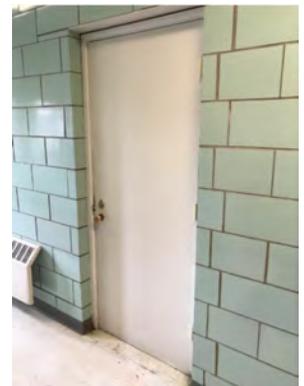
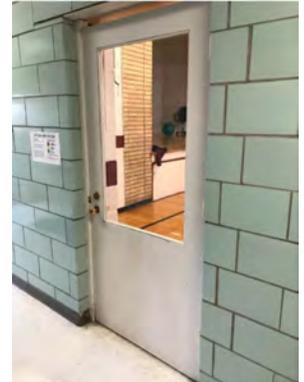
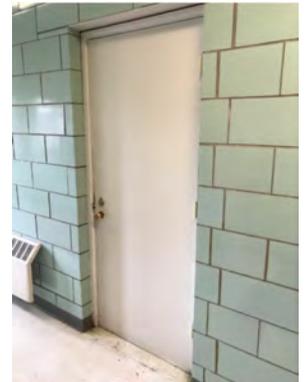
Interior doors include non-rated 3 x 7 Wd (wood) door and frame with hinges, lockset and closer. Includes finished door and frame. Years remaining have been increased because the system is currently functioning, however the system is beyond its useful life and should be budgeted for repair/replacement.

Auto generated renewal for Swinging Doors - 3 x 7 Wd - 1955. System Description: Interior doors include non-rated 3 x 7 Wd (wood) door and frame with hinges, lockset and closer. Includes finished door and frame. Years remaining have been increased because the system is currently functioning, however the system is beyond its useful life and should be budgeted for repair/replacement.

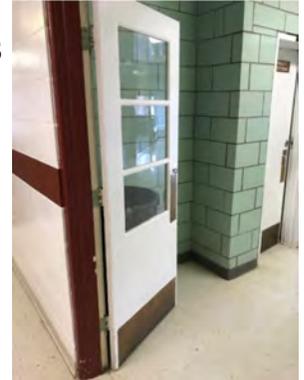
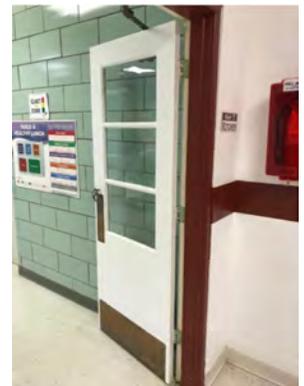
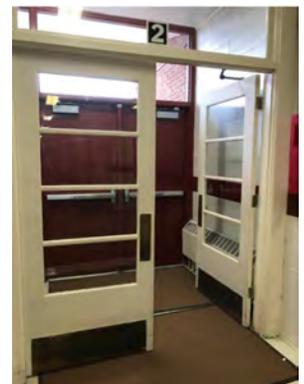
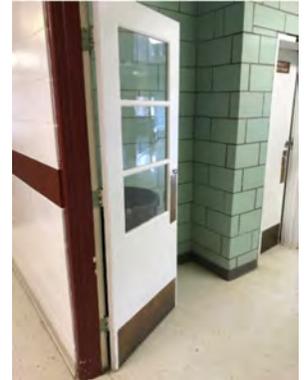
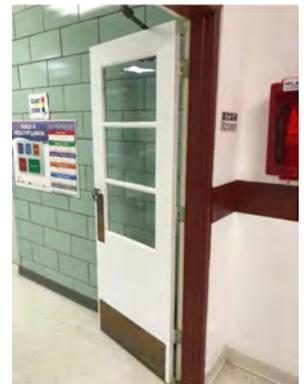
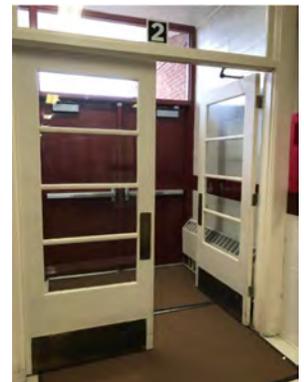
Interior doors include a pair of non-rated 3 x 7 Wd (wood) doors and frame with hinges, locksets and closers. Includes finished doors and frame. Years remaining have been increased because the system is currently functioning, however the system is beyond its useful life and should be budgeted for repair/replacement.

Auto generated renewal for Swinging Doors - Pair - 6 x 7 Wd - 1955. System Description: Interior doors include a pair of non-rated 3 x 7 Wd (wood) doors and frame with hinges, locksets and closers. Includes finished doors and frame. Years remaining have been increased because the system is currently functioning, however the system is beyond its useful life and should be budgeted for repair/replacement.

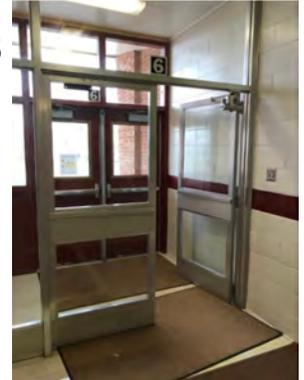
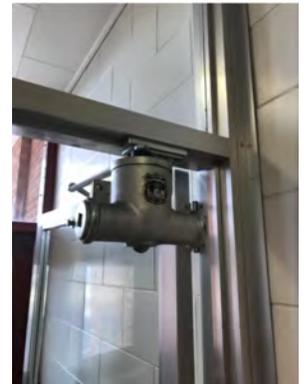
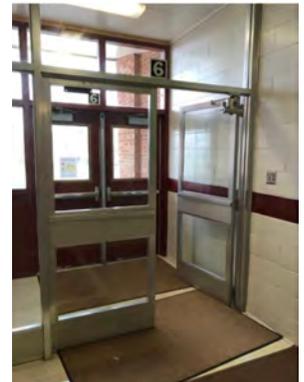
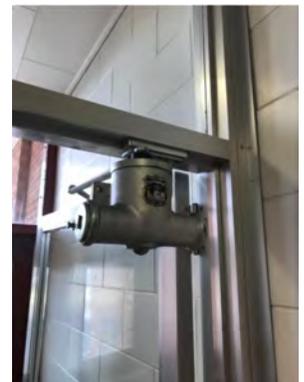
Swinging Doors - 6 x 7 Storefront - 1955 Renewal

The interior doors include a pair of swinging glazed aluminum storefront with glazed transom, aluminum frame, hardware and closers. Years remaining have been increased because the system is currently functioning, however the system is beyond its useful life and should be budgeted for repair/replacement.

Auto generated renewal for Swinging Doors - 6 x 7 Storefront - 1955. System Description: The interior doors include a pair of swinging glazed aluminum storefront with glazed transom, aluminum frame, hardware and closers. Years remaining have been increased because the system is currently functioning, however the system is beyond its useful life and should be budgeted for repair/replacement.

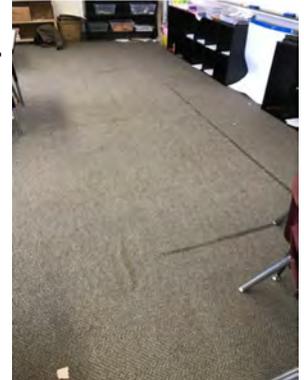
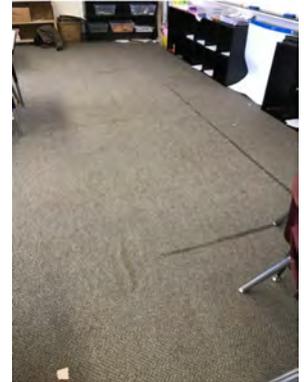
Floor finishes include carpeting and base. The system is failing and should be budgeted for repair/replacement.

Auto generated renewal for Carpeting - Broadloom - 1990. System Description: Floor finishes include carpeting and base. The system is failing and should be budgeted for repair/replacement.

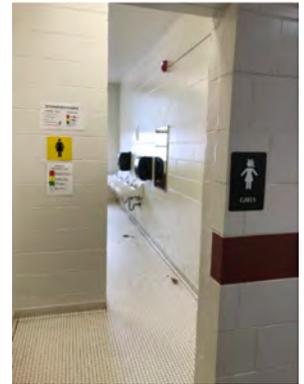
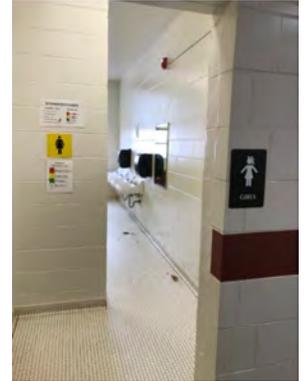
Floor finishes include ceramic tile and base. Years remaining have been increased because the system is currently functioning, however the system is beyond its useful life and should be budgeted for repair/replacement.

Auto generated renewal for Ceramic Tile - 1955. System Description: Floor finishes include ceramic tile and base. Years remaining have been increased because the system is currently functioning, however the system is beyond its useful life and should be budgeted for repair/replacement.

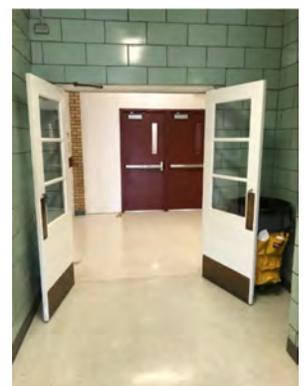
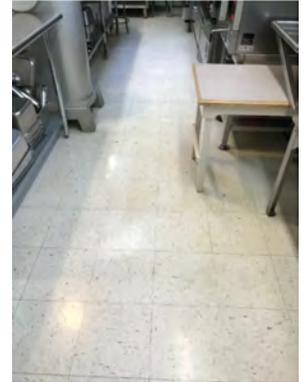
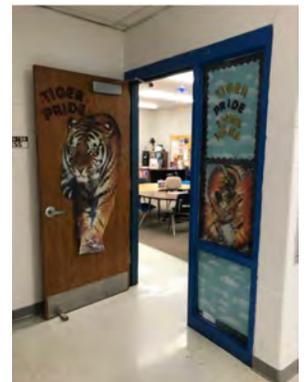
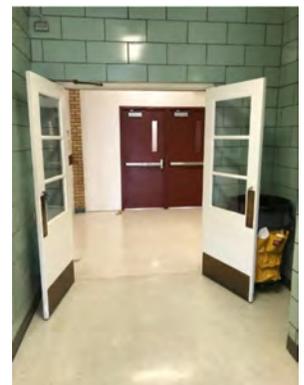
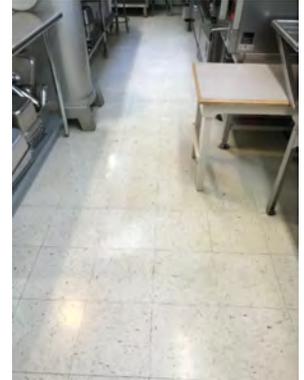
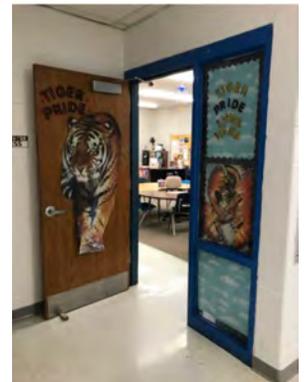
Floor finishes include areas of VCT (Vinyl Composition Tile) flooring and base. Years remaining have been increased because the system is currently functioning, however the system is beyond its useful life and should be budgeted for repair/replacement.

Auto generated renewal for VCT - 2000. System Description: Floor finishes include areas of VCT (Vinyl Composition Tile) flooring and base. Years remaining have been increased because the system is currently functioning, however the system is beyond its useful life and should be budgeted for repair/replacement.

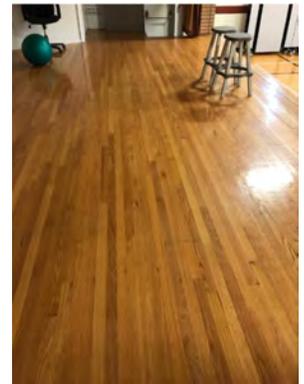
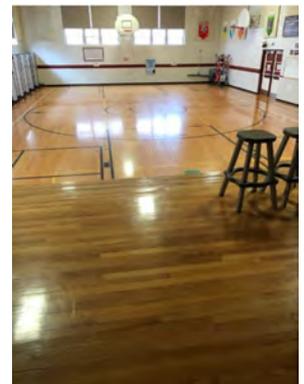
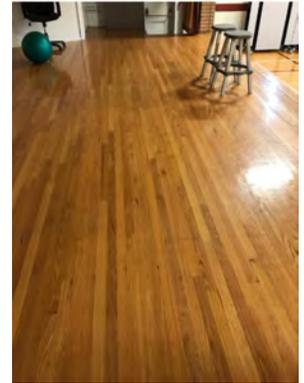
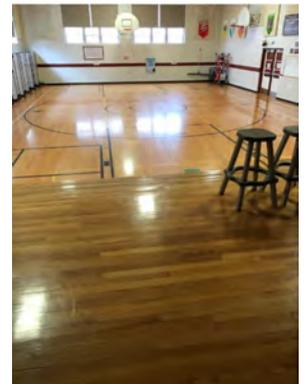
Floor finishes include finished wood strip flooring and finished wood base. Assumed on concrete over sleepers. Years remaining have been increased because the system is currently functioning, however the system is beyond its useful life and should be budgeted for repair/replacement.

Auto generated renewal for Wood Flooring - Premium. System Description: Floor finishes include finished wood strip flooring and finished wood base. Assumed on concrete over sleepers. Years remaining have been increased because the system is currently functioning, however the system is beyond its useful life and should be budgeted for repair/replacement.

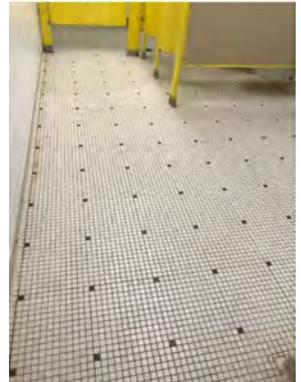
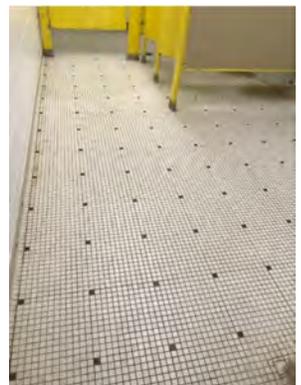
Current Age: 34 years	Year Installed: 1986
Exp. Use. Life: 25 years	Obs. Yrs. Rem: 5 years
Quantity: 800 SF	Unit Cost: \$21.48
Insp. Date: 3/10/20	Inspector: Mark Hillen

Floor finishes include ceramic tile and base. Years remaining have been increased because the system is currently functioning, however the system is beyond its useful life and should be budgeted for repair/replacement.

Cost: \$21,483	Priority: 3 - Due within 5 Years of Inspection
Action Date: 3/10/25	Prime Sys: Floor Finishes
	Action: Ceramic Tile - 1986 Renewal

Auto generated renewal for Ceramic Tile - 1986. System Description: Floor finishes include ceramic tile and base. Years remaining have been increased because the system is currently functioning, however the system is beyond its useful life and should be budgeted for repair/replacement.

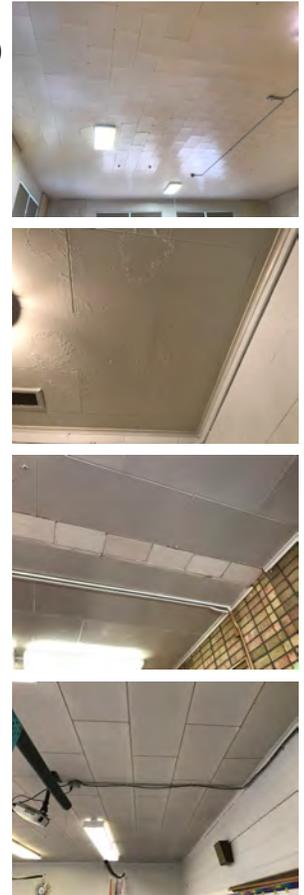
Ceiling finishes included suspended ACT (Acoustic Ceiling Tile) system. Years remaining have been increased because the system is currently functioning, however the system is beyond its useful life and should be budgeted for repair/replacement.

Auto generated renewal for ACT System - 1955. System Description: Ceiling finishes included suspended ACT (Acoustic Ceiling Tile) system. Years remaining have been increased because the system is currently functioning, however the system is beyond its useful life and should be budgeted for repair/replacement.

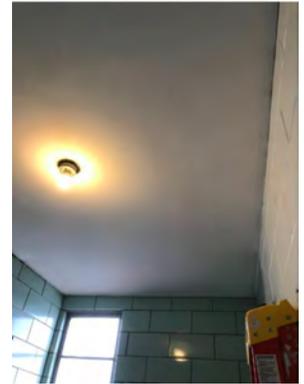
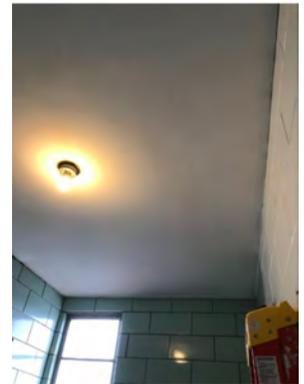
Ceiling finishes include GWB (Gypsum Wall Board) taped, finished and painted with primer and 2 finish coats. Years remaining have been increased because the system is currently functioning, however the system is beyond its useful life and should be budgeted for repair/replacement.

Auto generated renewal for GWB Taped and Finished - 1955. System Description: Ceiling finishes include GWB (Gypsum Wall Board) taped, finished and painted with primer and 2 finish coats. Years remaining have been increased because the system is currently functioning, however the system is beyond its useful life and should be budgeted for repair/replacement.

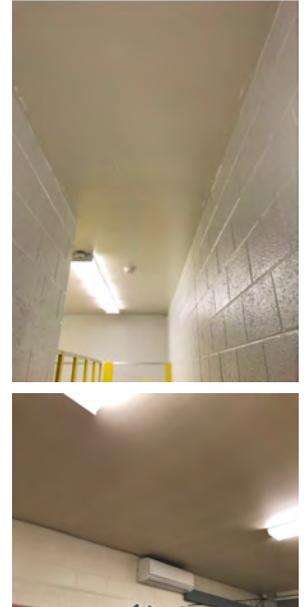
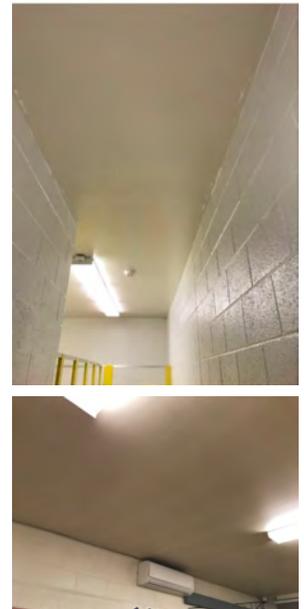
GWB Taped and Finished - 1986 Renewal

Ceiling finishes include GWB (Gypsum Wall Board) taped, finished and painted with primer and 2 finish coats. Years remaining have been increased because the system is currently functioning, however the system is beyond its useful life and should be budgeted for repair/replacement.

Auto generated renewal for GWB Taped and Finished - 1986. System Description: Ceiling finishes include GWB (Gypsum Wall Board) taped, finished and painted with primer and 2 finish coats. Years remaining have been increased because the system is currently functioning, however the system is beyond its useful life and should be budgeted for repair/replacement.

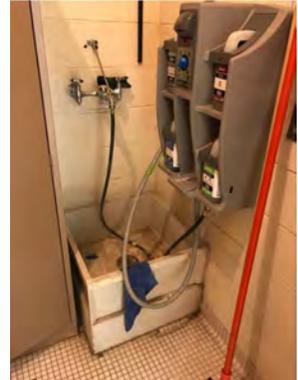
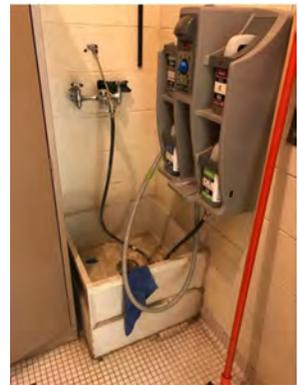
Current Age: 34 years	Year Installed: 1986
Exp. Use. Life: 30 years	Obs. Yrs. Rem: 5 years
Quantity: 10,000 SF	Unit Cost: \$0.47
Insp. Date: 3/10/20	Inspector: Mark Hillen

The plumbing fixtures include custodial/utility sinks. Includes rough-in and faucet. Years remaining have been increased because the system is currently functioning, however the system is beyond its useful life and should be budgeted for repair/replacement.

Cost: \$5,891	Priority: 3 - Due within 5 Years of Inspection
Action Date: 3/10/25	Prime Sys: Plumbing Fixtures
	Action: Custodial/Utility Sinks - 1986 Renewal

Auto generated renewal for Custodial/Utility Sinks - 1986. System Description: The plumbing fixtures include custodial/utility sinks. Includes rough-in and faucet. Years remaining have been increased because the system is currently functioning, however the system is beyond its useful life and should be budgeted for repair/replacement.

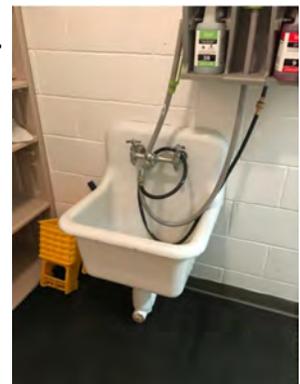
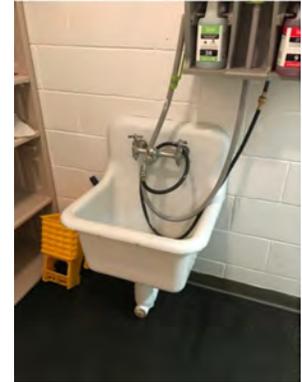
Current Age: 65 years **Year Installed:** 1955
Exp. Use. Life: 30 years **Obs. Yrs. Rem:** 5 years
Quantity: 26,600 SF **Unit Cost:** \$0.47
Insp. Date: 3/10/20 **Inspector:** Mark Hillen

The plumbing fixtures include custodial/utility sinks. Includes rough-in and faucet. Years remaining have been increased because the system is currently functioning, however the system is beyond its useful life and should be budgeted for repair/replacement.

Auto generated renewal for Custodial/Utility Sinks - 1955. System Description: The plumbing fixtures include custodial/utility sinks. Includes rough-in and faucet. Years remaining have been increased because the system is currently functioning, however the system is beyond its useful life and should be budgeted for repair/replacement.

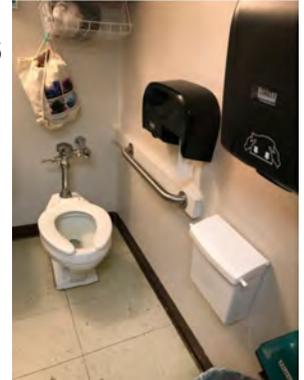
The restroom fixtures include urinals, water closets and lavatories. Years remaining have been increased because the system is currently functioning, however the system is beyond its useful life and should be budgeted for repair/replacement.

Auto generated renewal for Restroom Fixtures - 1990. System Description: The restroom fixtures include urinals, water closets and lavatories. Years remaining have been increased because the system is currently functioning, however the system is beyond its useful life and should be budgeted for repair/replacement.

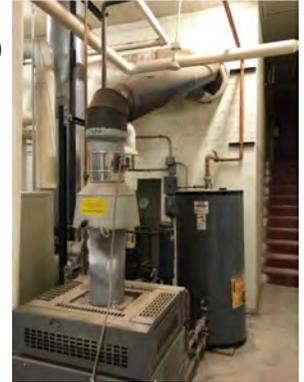
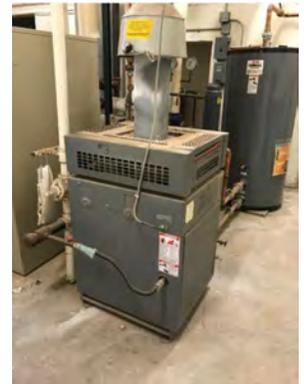
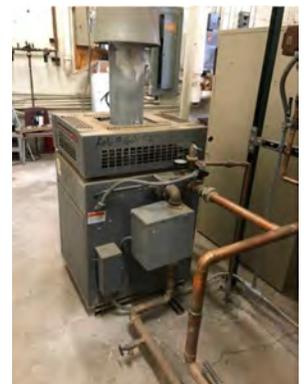
The domestic hot water is provided by a gas-fired, water heater, with recirculation pump. Years remaining have been increased because the system is currently functioning, however the system is beyond its useful life and should be budgeted for repair/replacement.

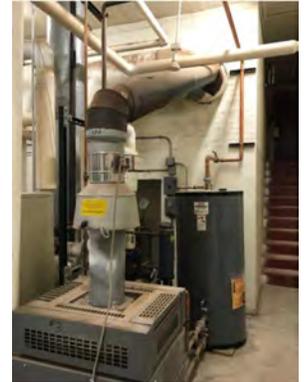
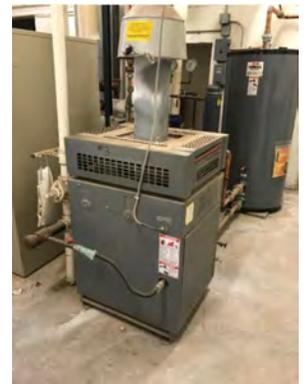
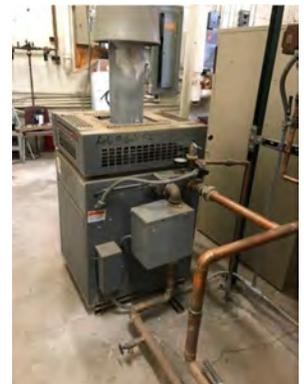
Auto generated renewal for Water Heater - Gas - 1994. System Description: The domestic hot water is provided by a gas-fired, water heater, with recirculation pump. Years remaining have been increased because the system is currently functioning, however the system is beyond its useful life and should be budgeted for repair/replacement.

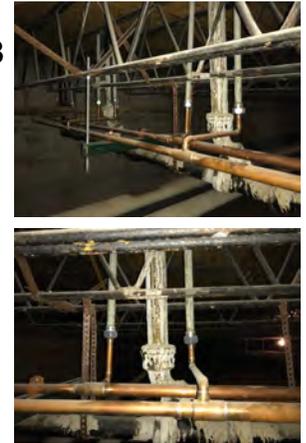
The building domestic water distribution system includes original galvanized water lines joined with modern copper lines. The water heater is captured in a separate system. Years remaining have been increased because the system is currently functioning, however the system is beyond its useful life and should be budgeted for repair/replacement.

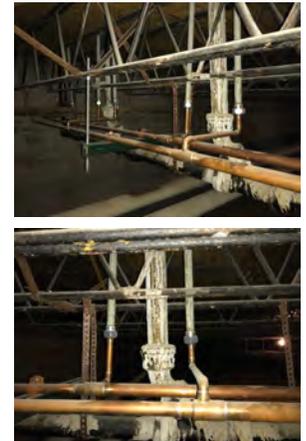
Auto generated renewal for Water Dist Complete - 1955. System Description: The building domestic water distribution system includes original galvanized water lines joined with modern copper lines. The water heater is captured in a separate system. Years remaining have been increased because the system is currently functioning, however the system is beyond its useful life and should be budgeted for repair/replacement.

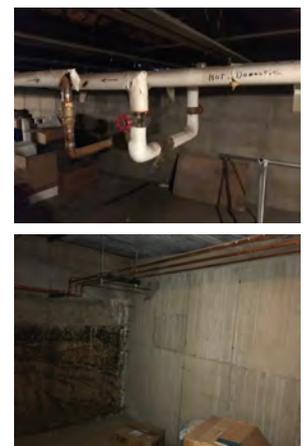
The building domestic water distribution system includes a four inch main line, water meter, backflow preventer, with rough ins included. The water heater is captured in a separate system.

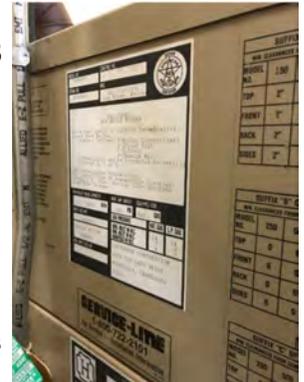
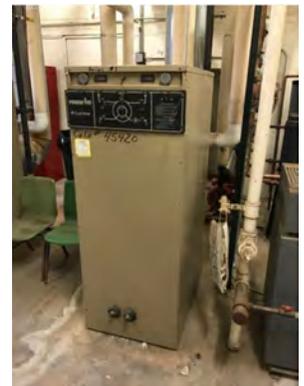
Heat is provided by a gas-fired HW (hot water) boiler. Full redundancy is included. Years remaining have been increased because the system is currently functioning, however the system is beyond its useful life and should be budgeted for repair/replacement.

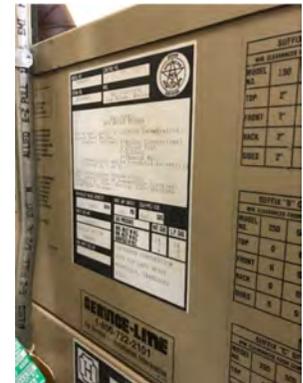
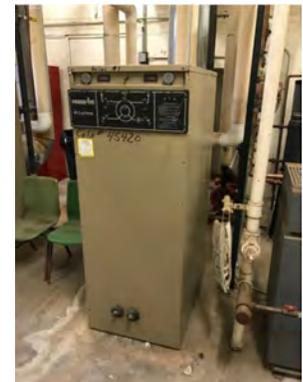
Auto generated renewal for Boiler HW - Gas-Fired w/Redundancy. System Description: Heat is provided by a gas-fired HW (hot water) boiler. Full redundancy is included. Years remaining have been increased because the system is currently functioning, however the system is beyond its useful life and should be budgeted for repair/replacement.

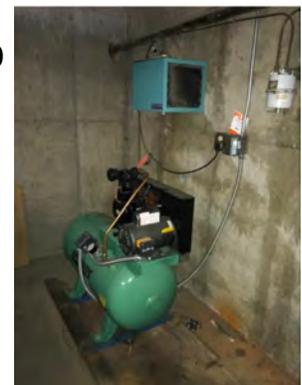
The 1986 Addition includes a pneumatic HVAC control system with air supply, controls and sensors. Note that heat regulation for the original 1955 structure is controlled by manually turning hot water valves open and shut in individual classrooms. Years remaining have been increased because the system is currently functioning, however the system is beyond its useful life and should be budgeted for repair/replacement.

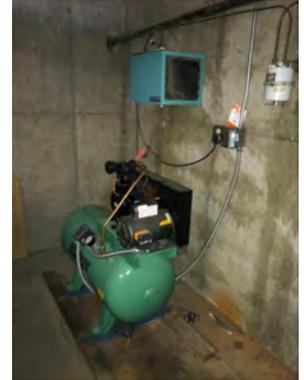
Auto generated renewal for Pneumatic Controls. System Description: The 1986 Addition includes a pneumatic HVAC control system with air supply, controls and sensors. Note that heat regulation for the original 1955 structure is controlled by manually turning hot water valves open and shut in individual classrooms. Years remaining have been increased because the system is currently functioning, however the system is beyond its useful life and should be budgeted for repair/replacement.

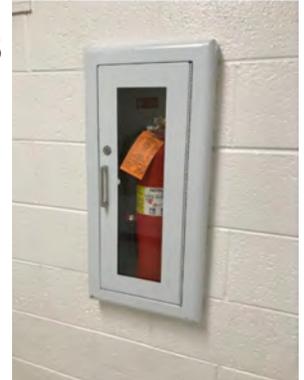
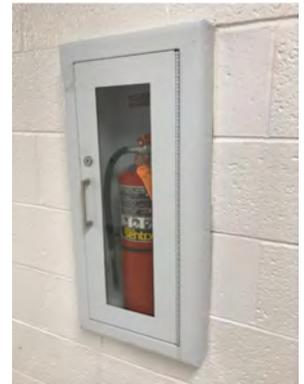
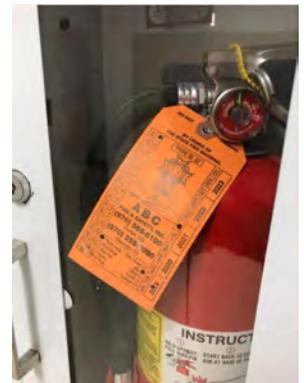
Handheld type dry chemical fire extinguishers are located throughout the building. Includes cabinets.

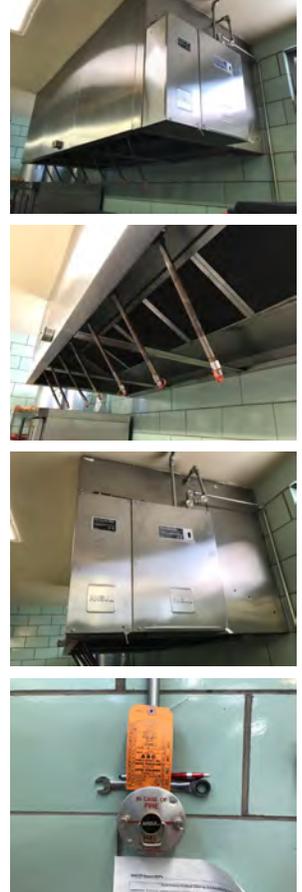
Auto generated renewal for Kitchen Hood Suppression. System Description: System includes a chemical fire suppression system for the kitchen. Fire suppression includes fusible links, manual pull stations, 3 gallon tanks, nozzles, and control panels. Hood included under a separate system. Years remaining have been increased because the system is currently functioning, however the system is beyond its useful life and should be budgeted for repair/replacement.

Cost: \$12,935 **Priority:** 3 - Due within 5 Years of Inspection
Action Date: 3/10/25 **Prime Sys:** Fire Protection
Action: Kitchen Hood Suppression Renewal

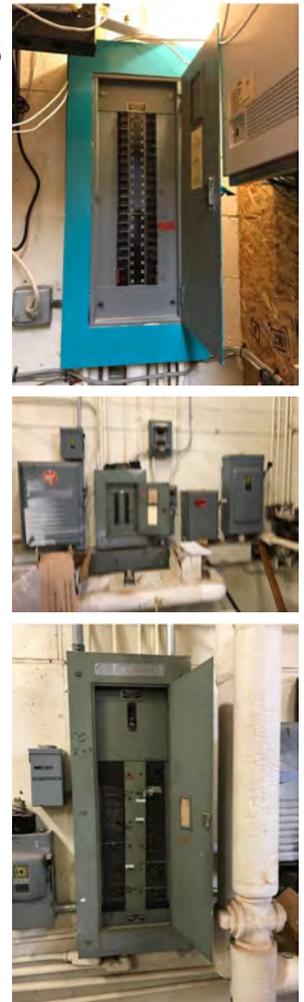
The electrical distribution system for this building includes panelboards, feeders, and associated equipment. Years remaining have been increased because the system is currently functioning, however the system is beyond its useful life and should be budgeted for repair/replacement.

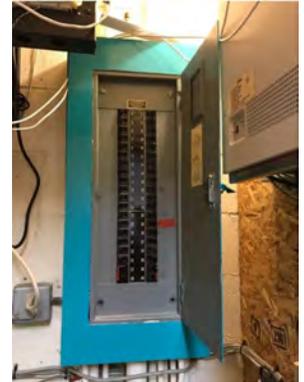
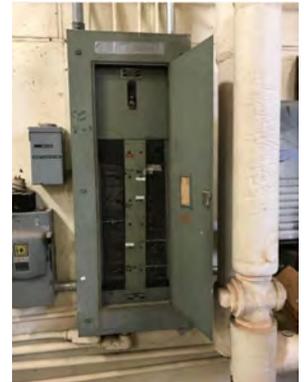
Auto generated renewal for Distribution Equipment, Panelboards, and Feeders - 1955. System Description: The electrical distribution system for this building includes panelboards, feeders, and associated equipment. Years remaining have been increased because the system is currently functioning, however the system is beyond its useful life and should be budgeted for repair/replacement.

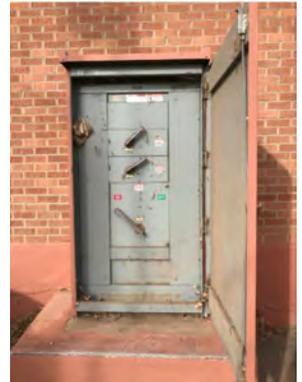
The building includes an electrical service, which includes incoming feeders, main panel, and metering. Years remaining have been increased because the system is currently functioning, however the system is beyond its useful life and should be budgeted for repair/replacement.

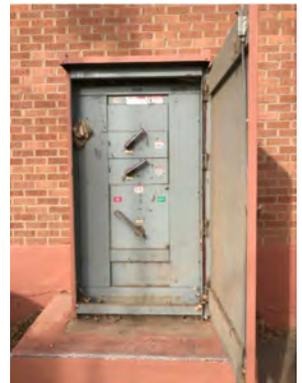
Auto generated renewal for Main Electrical Service - 800A. System Description: The building includes an electrical service, which includes incoming feeders, main panel, and metering. Years remaining have been increased because the system is currently functioning, however the system is beyond its useful life and should be budgeted for repair/replacement.

Cost:	\$76,551	Priority:	3 - Due within 5 Years of Inspection
Action Date:	3/10/25	Prime Sys:	Low Tension Service and Dist.
		Action:	Main Electrical Service - 800A Renewal

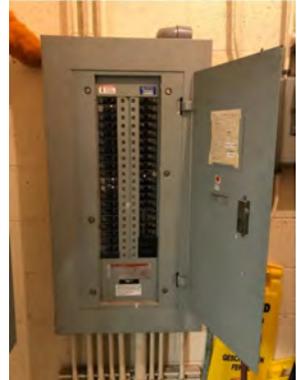
Distribution Equipment, Panelboards, and Feeders - 1986

The electrical distribution system for this building includes panelboards, feeders, and associated equipment. Years remaining have been increased because the system is currently functioning, however the system is beyond its useful life and should be budgeted for repair/replacement.

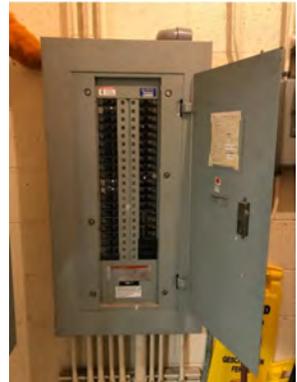
Auto generated renewal for Distribution Equipment, Panelboards, and Feeders - 1986. System Description: The electrical distribution system for this building includes panelboards, feeders, and associated equipment. Years remaining have been increased because the system is currently functioning, however the system is beyond its useful life and should be budgeted for repair/replacement.

Cost:	\$88,738	Priority:	3 - Due within 5 Years of Inspection
Action Date:	3/10/25	Prime Sys:	Low Tension Service and Dist.
		Action:	Distribution Equipment, Panelboards, and Feeders - 1986 Renewal

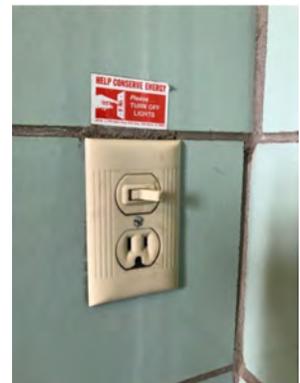
Branch wiring for this building includes interior and exterior branch wiring, devices, and utilization equipment. Years remaining have been increased because the system is currently functioning, however the system is beyond its useful life and should be budgeted for repair/replacement.

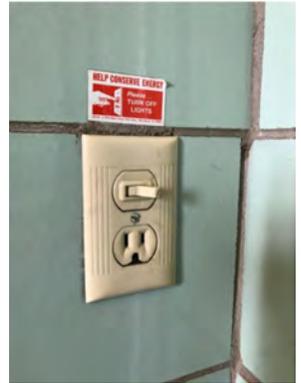
Auto generated renewal for Branch Wiring - Equipment & Devices. System Description: Branch wiring for this building includes interior and exterior branch wiring, devices, and utilization equipment. Years remaining have been increased because the system is currently functioning, however the system is beyond its useful life and should be budgeted for repair/replacement.

Cost: \$17,896 **Priority:** 3 - Due within 5 Years of Inspection
Action Date: 3/10/25 **Prime Sys:** Branch Wiring Devices
Action: Branch Wiring - Equipment & Devices Renewal

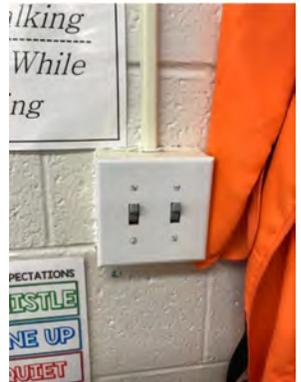
Branch wiring for this building includes interior and exterior branch wiring, devices, and utilization equipment. Years remaining have been increased because the system is currently functioning, however the system is beyond its useful life and should be budgeted for repair/replacement.

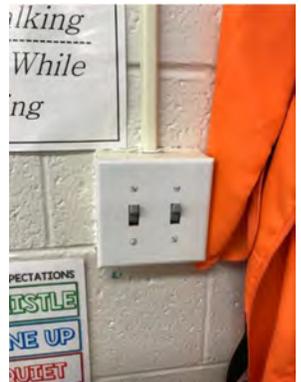
Auto generated renewal for Branch Wiring - Equipment & Devices - 1986. System Description: Branch wiring for this building includes interior and exterior branch wiring, devices, and utilization equipment. Years remaining have been increased because the system is currently functioning, however the system is beyond its useful life and should be budgeted for repair/replacement.

Cost: \$99,068 **Priority:** 3 - Due within 5 Years of Inspection
Action Date: 3/10/25 **Prime Sys:** Branch Wiring Devices
Action: Branch Wiring - Equipment & Devices - 1986 Renewal

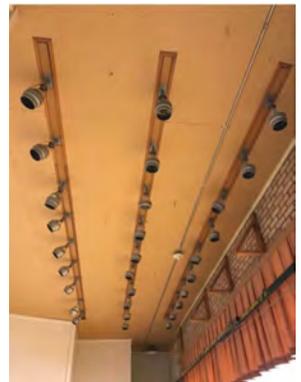
Auto generated renewal for Stage Lighting. System Description: Stage lighting includes master control panel, spots, borders and stage lights. Years remaining have been increased because the system is currently functioning, however the system is beyond its useful life and should be budgeted for repair/replacement.

Cost: \$37,727	Priority: 3 - Due within 5 Years of Inspection
Action Date: 3/10/25	Prime Sys: Lighting Equipment
	Action: Stage Lighting Renewal

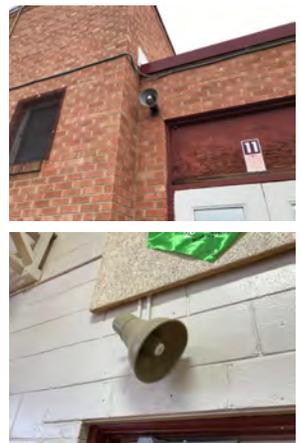
Auto generated renewal for Public Address System. System Description: The building includes a public address system. The public address system includes an amplifier, intercom/monitor, volume control, speakers, conduit and shielded wiring. Years remaining have been increased because the system is currently functioning, however the system is beyond its useful life and should be budgeted for repair/replacement.

Cost:	\$90,349	Priority:	3 - Due within 5 Years of Inspection
Action Date:	3/10/25	Prime Sys:	Public Address and Music Systems
		Action:	Public Address System Renewal

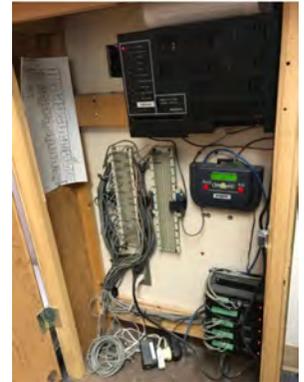
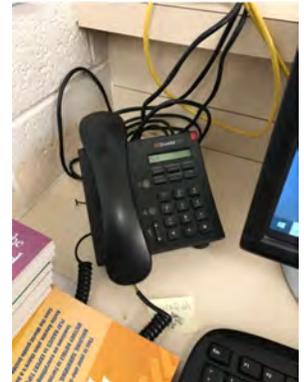
The building includes a telephone system. Years remaining have been increased because the system is currently functioning, however the system is beyond its useful life and should be budgeted for repair/replacement.

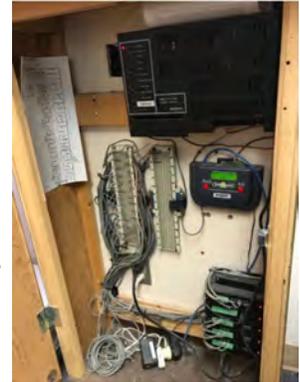
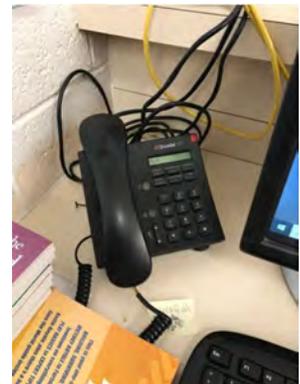
Auto generated renewal for Telephone System. System Description: The building includes a telephone system. Years remaining have been increased because the system is currently functioning, however the system is beyond its useful life and should be budgeted for repair/replacement.

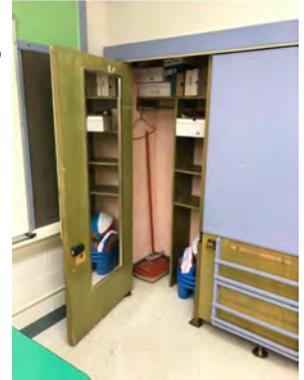
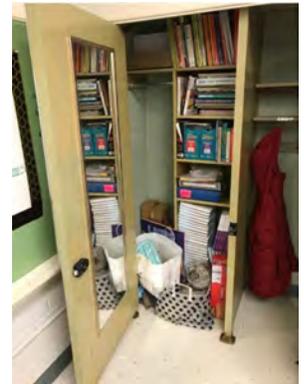
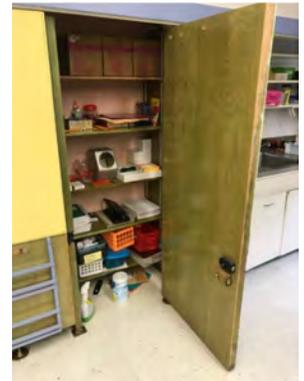
The building includes laminate casework, including wall and under-counter cabinets and counter-tops. Years remaining have been increased because the system is currently functioning, however the system is beyond its useful life and should be budgeted for repair/replacement.

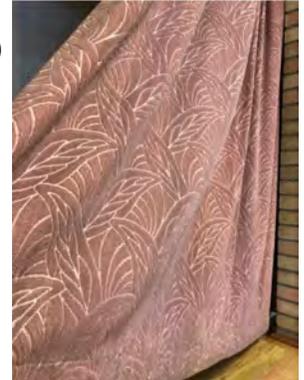
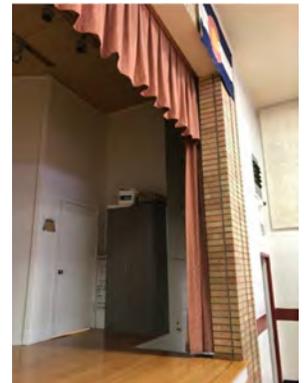
Equipment and furnishings include theater curtains. Years remaining have been increased because the system is currently functioning, however the system is beyond its useful life and should be budgeted for repair/replacement.

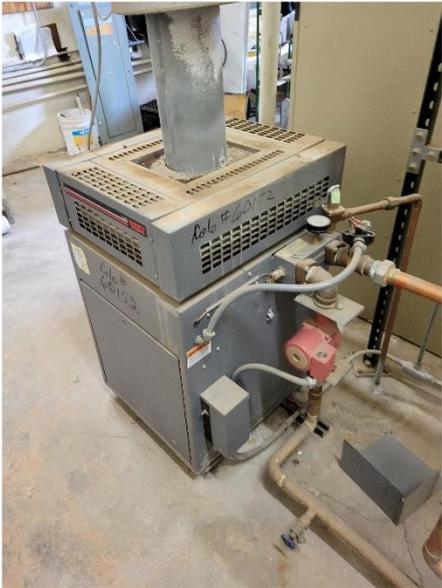
Image 2: Domestic Water Boiler

Plumbing – Replace the existing domestic hot water boiler (Lochinvar AWN200PM) with a pair of boilers each sized for 60-75% of the load and add master mixing valve to system. Galvanized domestic, sanitary and storm water piping in the 1955 portion of the building should be replaced.
